Geosynthetics as eco-friendly defence against erosion in arctic regions

Olivier Artières, John Lostumbo
TenCate Geosynthetics, Pendergrass, Georgia, USA
Arnstein Watn, Maj Gøril Glåmen Bæverfjord, Philippe Delmas
SINTEF, Trondheim, Norway
François Caquel
Laboratoire des Ponts et Chaussées de Nancy, Tomblaine, France
Lars Grande
NTNU, Trondheim, and UNIS, Longyearbyen, Norway
Arne Langeland
SNSG, Svalbard, Svea, Norway

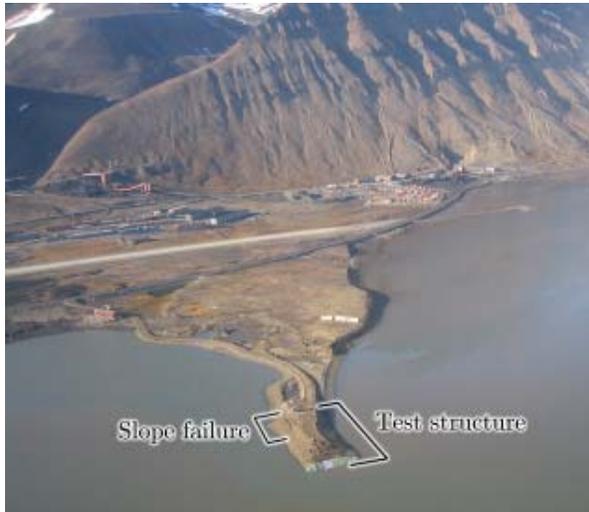
Figure 3. Aerial view of the breakwater.

A 50 meter long breakwater was built during the summer of 2006. The inclination of the embankment is 1:3.5 (Figures 3 and 4). Its top is 3.2 above datum and 5 m wide. The masses were extracted from the mountainsides surrounding Svea.

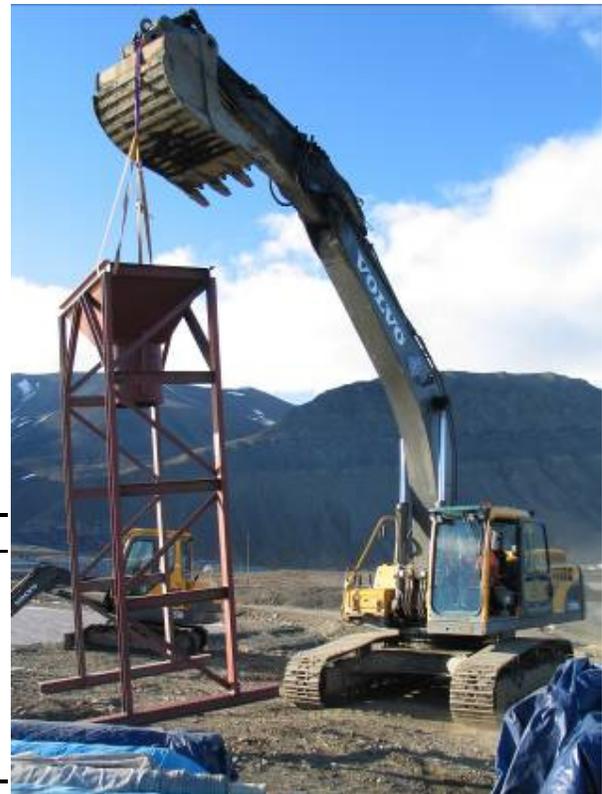
Figure 6. Elevated funnel used to fill the bags on site.

Filling equipment was designed for the project, consisting of a funnel and a box, which was attached to the arm of an excavator (Figure 6). The bags were filled with local masses. 70% of the masses had a diameter smaller than 19 mm. The construction took place in August 2006. The filling and installation of a bag took approximately 10 minutes and required two excavator operators and two bag operators. 150 bags were constructed in total (Figure 7).

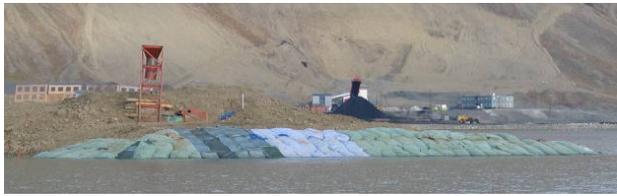
Figure 7. View and map of breakwater after construction (September 2006).

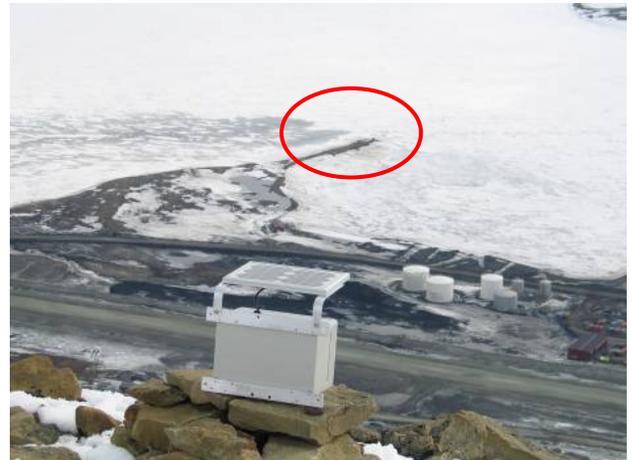
Figure 9. Time lapse camera on Liljevalchfjellet above Svea taking pictures of the sea ice in Sveasundet, May 22nd 2007. The experimental breakwater in the red circle (Caline, 2010)

Monitoring equipment including a tide and wave gauge, thermistor strings, a weather station and cameras were installed (Figures 8, 9 and 10).

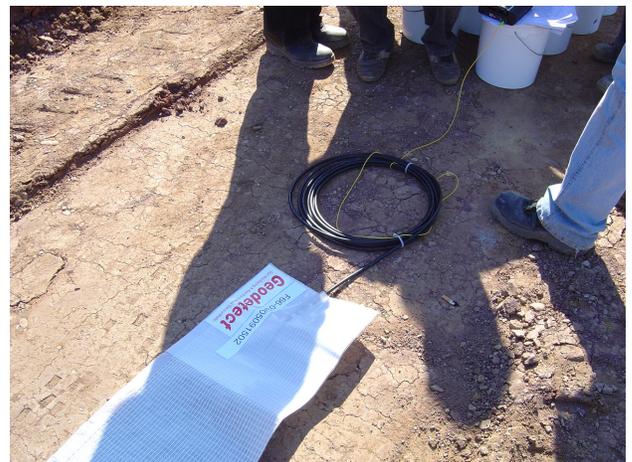
Figure 11. The TenCate GeoDetect® textile fiber optics sensor

The TenCate GeoDetect® S-FBG solution embodies a strip of geocomposite fabric, fiber optics, software and instrumentation to provide an innovative solution for the multi-functional requirements of a geotechnical application (Figure 11). It uses Fiber Bragg Gratings (FBG) technology to measure strain in soil structures as low as 0.02% with a spatial resolution of 1 m.

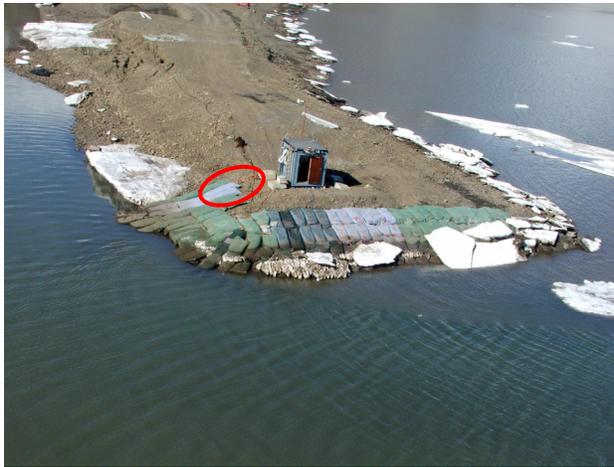
Figure 12. Location of the textile fiber optics sensor (red shape).

The strip was laid below the bags of the West corner (Figure 12). The strain measured between the installation in September 2006 and spring 2007 ranged between 0 to 0.1%, concluding to no significant movement of the bags, nor settlement of the slope. The connection cable (Figure

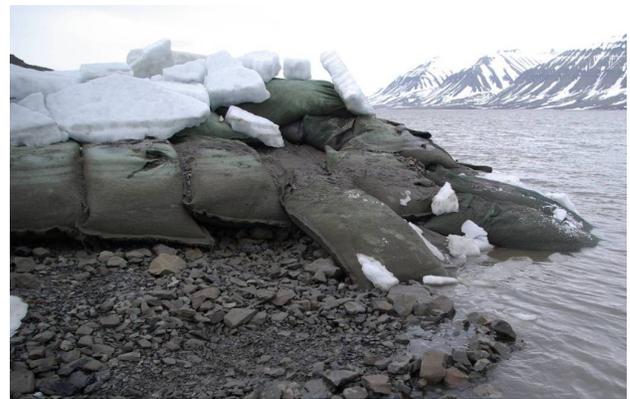
Figure 15. Visual inspection in 2009. Contact of the ice on the west corner One hole on bag 26, second on the left.

- 1 bag has been lost as it was without side-bags which were sampled the year before and gives more side impact from the ice blocks pushed over the bags from the East (or less probably from the West) (Figure 15);

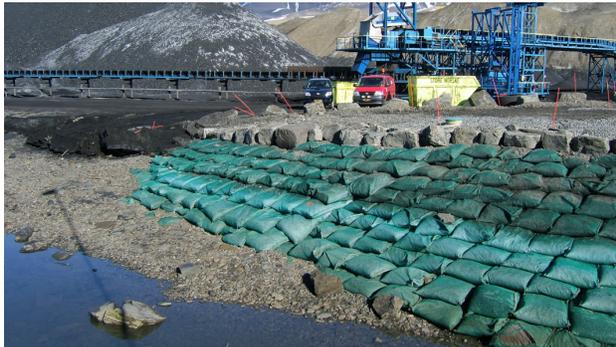
Figure 17. The Kapp Amsterdam quay wall stabilised with the geobags

The geobags solution is a real economical alternative to traditional rocks. For example, geobags were used to reinforce an existing quay previously protected with large rocks against scour erosion at the Kapp Amsterdam harbor in Svea, a few kilometers from the Barryneset experimental site (Figure 1). It consists in a slope stabilization built with 10 levels of geobags (Figure 17). Two years after installation, the results are very promising and will be published in other papers.
