SUBGRADE STABILIZATION, GAINESVILLE, ALACHUA FL

# Roadway Reconstruction

<b>Industry:</b>	Roadway Infrastructure
<b>Application:</b>	Subgrade Stabilization
<b>Location:</b>	Gainesville, Alachua County, FL
<b>Product:</b>	<b>MIRAFI® RS580i</b>

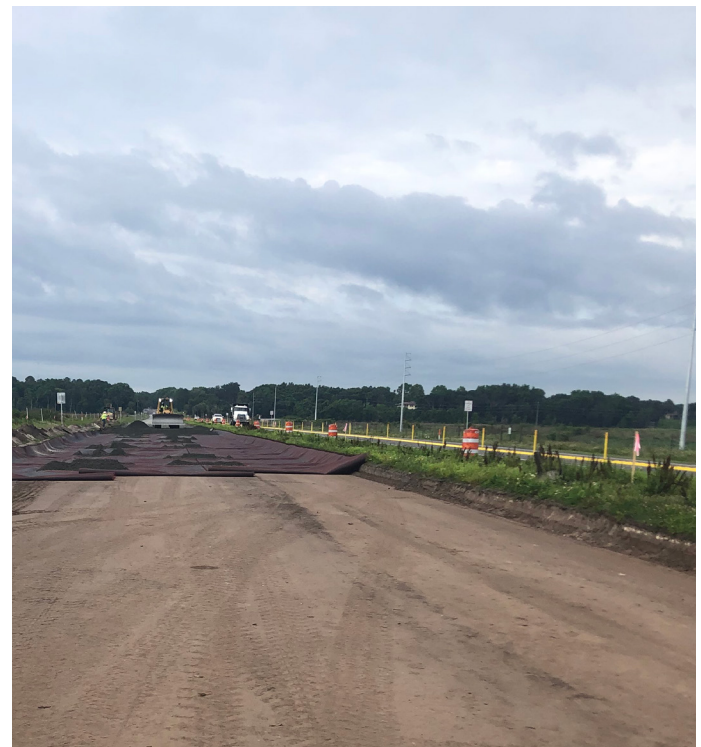
The design for the reconstructed roadway consisted of removing the existing asphalt and roadway base, with 105,000 sy (87,793 sm) MIRAFL RS580i placed directly on the exposed subgrade. No other subgrade stabilization methods were used. After the placement of the RS580i, 11 inches (28 cm) of graded aggregate base was placed and compacted. The last part of the design included the placement of the

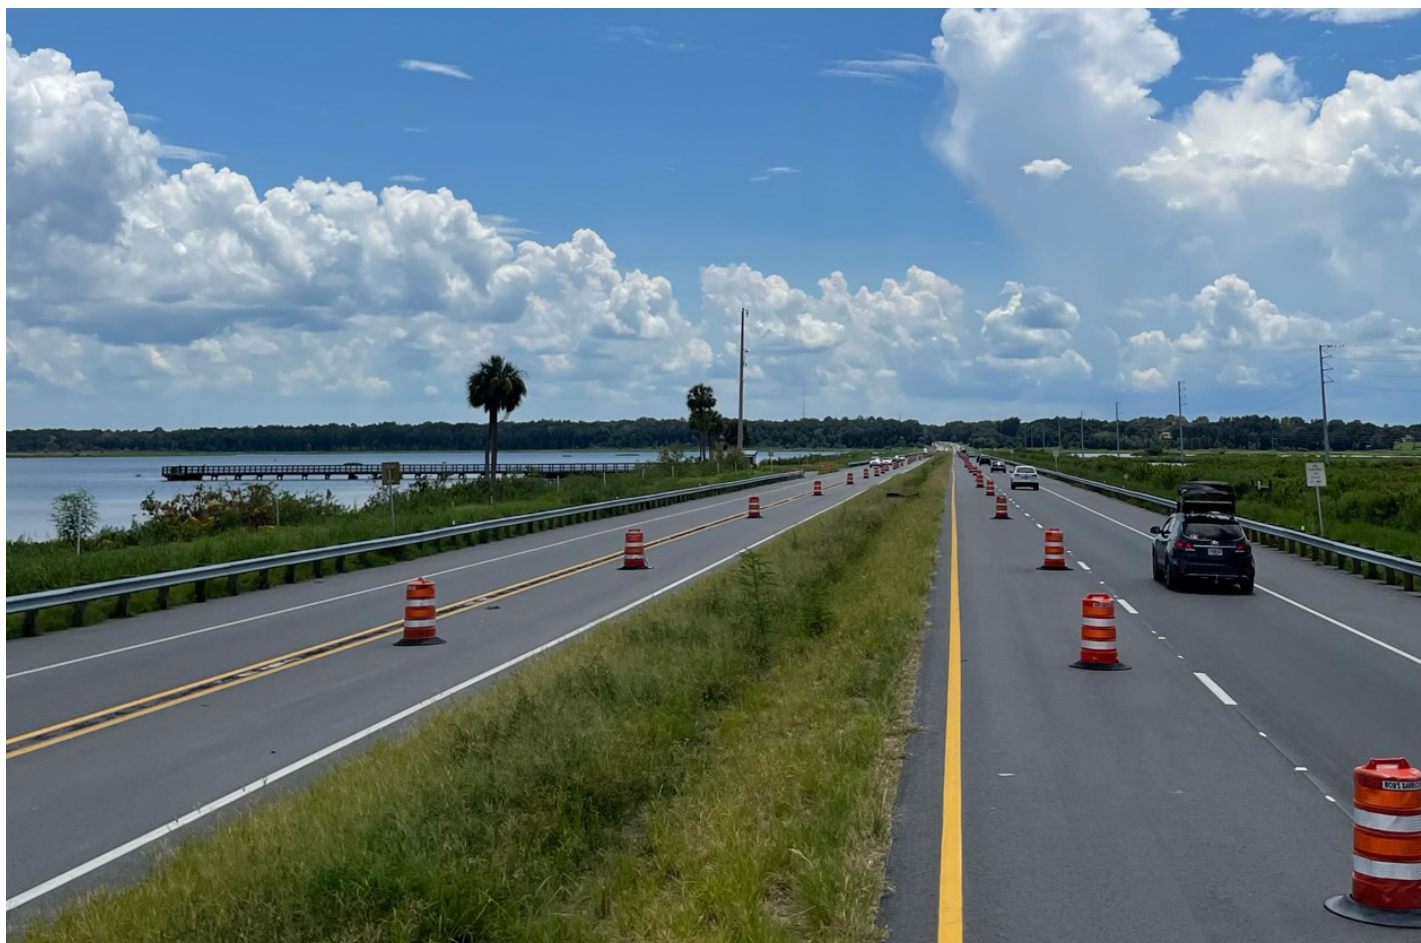
The reconstruction was complete in December 2021. Since reopening, the highway has endured multiple hurricanes and flood events. The high flow rate of RS580i and its ability to provide separation, has prevented fines and organics from contaminating the roadway base. The roadway continues to perform without needed maintenance and repair. To date, this is the largest FDOT installation of the RSi material.
