## Case Study

**application** | **Wooden Bridge Deck Repair**

**location** | **Ontario, Canada**

**product** | **Mirafi® MTK700 & FGC100**

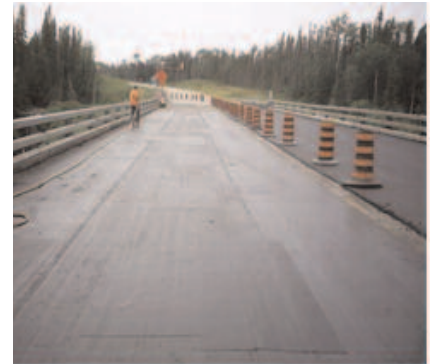
Mirafi® MTK700 placed on wooden bridge deck ready to have PGAC 52-34 asphalt tack coat applied.

moisture barrier and Mirafi® FGC100 Composite Fiberglass Paving grid for the interlayer materials. Mirafi® MTK700 is a unique and cost effective waterproofing membrane comprised of self-adhering rubberized asphalt and durable polypropylene woven fabric. A peel-n-stick release paper covers the self-adhesive mastic, and is removed prior to installation. Mirafi® FGC100 is composed of a high modulus 100kN/m (6,852lb/ft) fiberglass paving grid with a 139g/m<sup>2</sup> (4.0oz/yd<sup>2</sup>) nonwoven geotextile bonded to the back side. Mirafi® FGC paving grid is specifically designed to provide high strength at very low strains (less than 2% strain). This product property, commonly referred to as tensile modulus, is the key to adding reinforcement to a paved structure. The high strength at low strains is key to retarding reflective cracking that occurs in asphalt pavement overlays. The nonwoven paving fabric, with a properly applied tack coat, creates an excellent moisture barrier and provides good contact with the existing pavement.

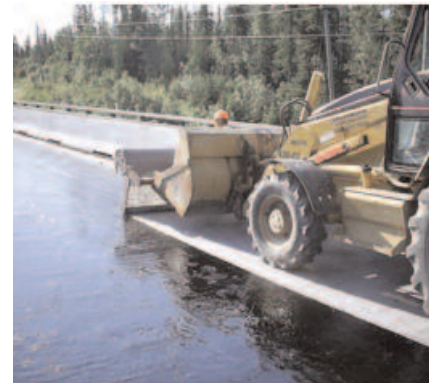
Placement of Mirafi® FGC100 with tractor mounted lay down-rig.

The surface was first cleaned and then Mirafi® MTK700 was applied, a PGAC 52-34 asphalt emulsion was applied at a application rate of 0.29 kg/m<sup>2</sup> (0.25-0.27gal/yd<sup>2</sup>) using a mobile hand spray unit. Temperature of the PGAC was approximately 138 C. Next, using a paving grid lay down rig mounted to a backhoe, the contractor started to install Mirafi® FGC100. Any wrinkles were slit and relaid flat. Once laid, Mirafi® FGC100 was stapled to the bridge deck with 50mm (2in) galvanized staples. Almost immediately after the paving grid was installed, a thunderstorm came through and soaked it. The contractor had to completely dry the system out with blowers. If this was not done, when the asphalt is placed, steam would have been generated which would have adversely affected the bond of the asphalt to Mirafi® FGC. Once dried, 40mm (1.5in) of asphalt was placed.

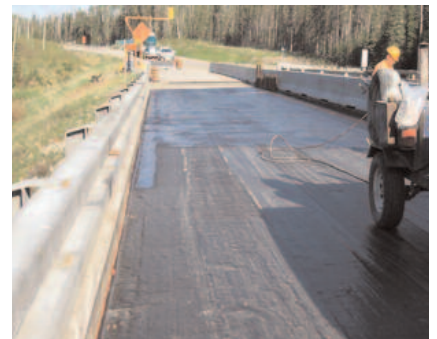
Asphalt tack coat being applied to Mirafi® MTK700.

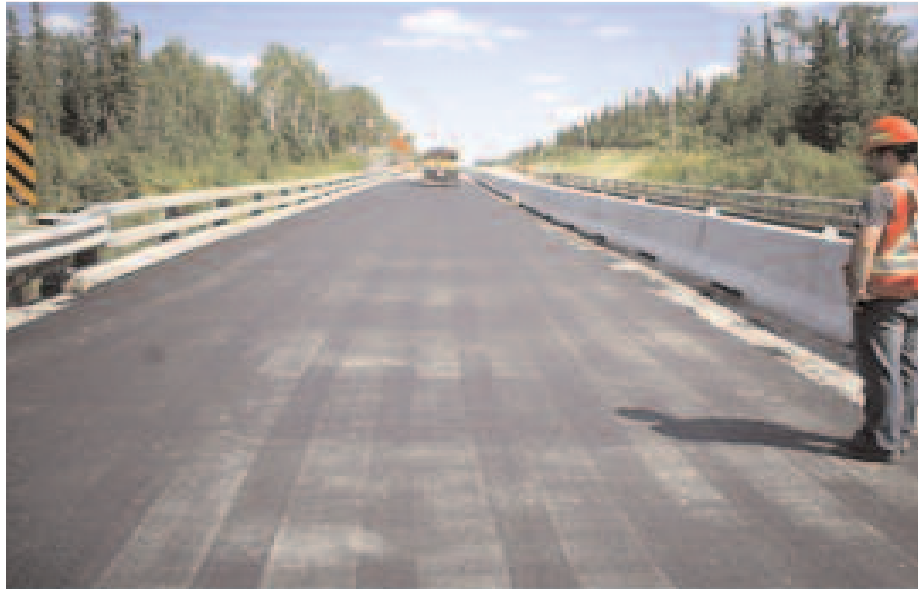
40mm (1.5in) of asphalt has been placed over Mirafi® FGC100 and is being compacted.

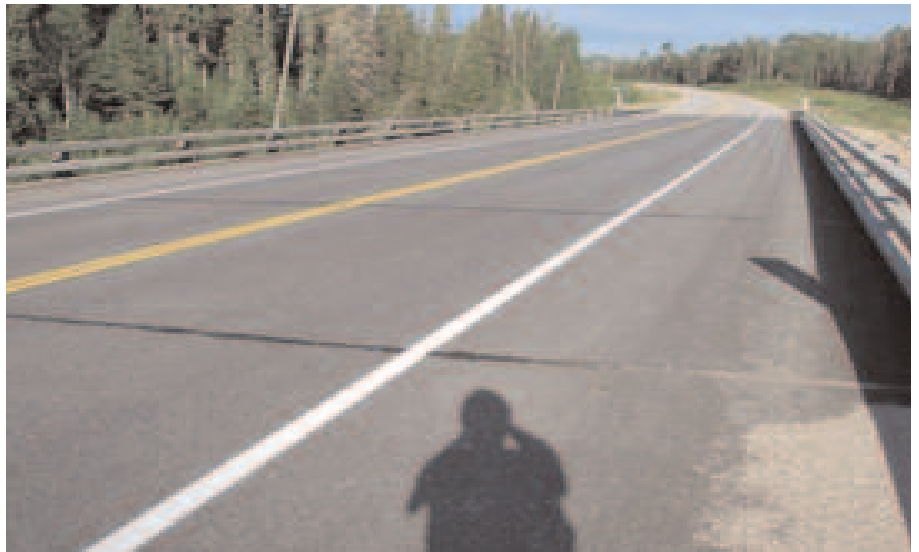
Mirafi® MTK700 and FGC100 were installed in June 2009 and have now gone through 2 winters. The pavement is showing no signs of distress.

Completed bridge deck one year after completion.
