CASE STUDY

Saturated Soils in Elko, Nevada Mine

Mirafi[®] H₂Ri

Tunnel Access Stabilization

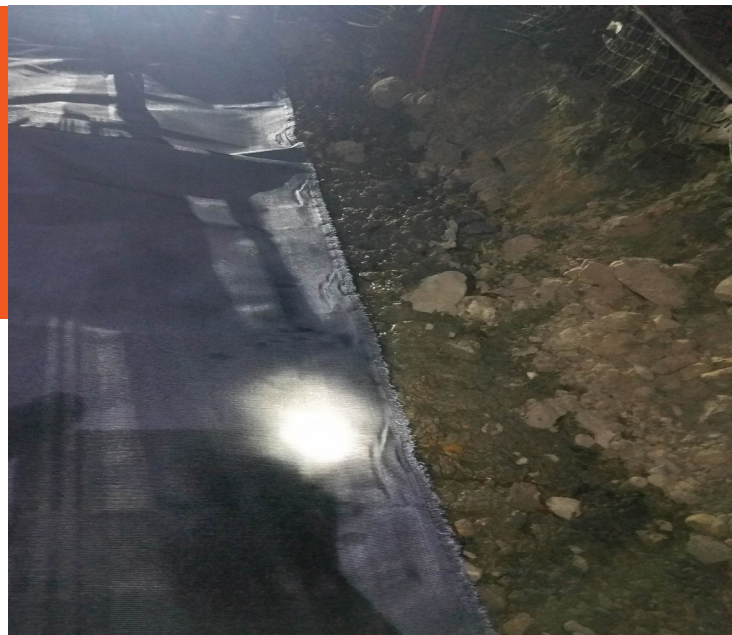
A mine site in Elko, NV was experiencing trouble with operating equipment, specifically the tunnels spread throughout the project site. The tunnel floors were susceptible to trapping moisture, creating saturated soil which was a problematic for the mine workers and maintenance crews. It was a regular occurrence for the mine vehicles to end up stuck in the tunnels from sinking saturated areas.

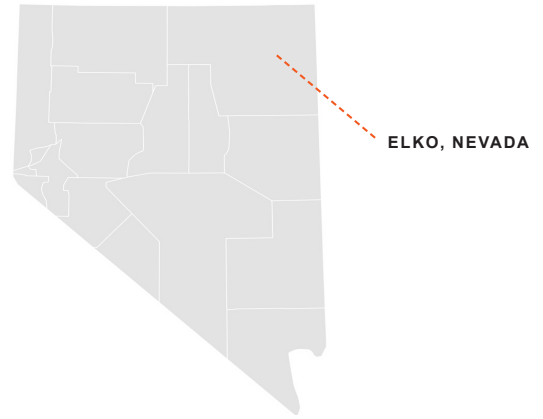
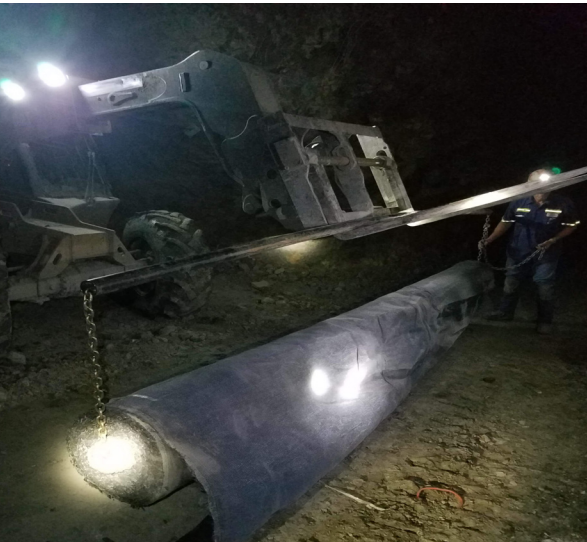
Mirafi® H₂Ri was placed over the existing soils and expelled into drainage channels on either side of the mine tunnel. The 17 ft. wide roll was a perfect width to cover the roadway and no overlaps were required. Pit run gravel was placed over the H₂Ri. As soon as the gravel was placed, the project team witnessed squeezing of the moisture out of the subgrade soils and into the drainage zones. Consolidation of the soils was occurring before their eyes. With more placement of gravel, the section firmed up and provided a stable base for mine equipment trafficking. Light compaction was achieved through trafficking vehicles over the placed gravel.
