Case Study

application | Test Section for Haul Roads
location | South Central, US
product | Mirafi® HP270

THE CHALLENGE

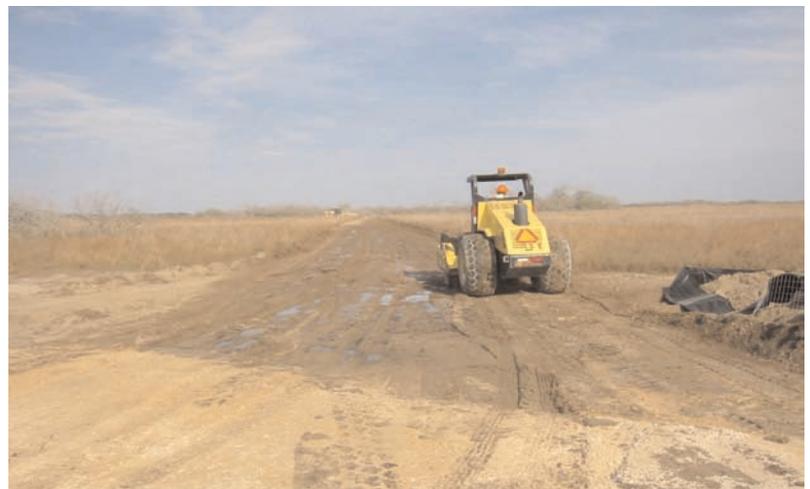
Wet subbase before placing geotextile.

The haul road area at the site was stripped of vegetation and then the subgrade was wetted down and rolled 5 times with a smooth drum roller until minimum deformation of the subgrade occurred under loading. Two roll widths of Mirafi® HP270 geotextile were placed for each 20 ft wide road section. Because of high residual water table and the potential for flooding of the site during rain events, a raise in grade was required at some locations. Before installing the geotextile, a sheep's foot roller was used to compact the existing soil and light vegetation, then suitable fill placed where they needed to raise the grade above standing water elevation. After the subgrade was leveled, Mirafi® HP270 geotextile was installed and the caliche was placed, graded and compacted. The required thickness of the caliche depended on the elevation of the water table adjacent to the roadways and whether the soil contained more sand than silt. An approximate 8" aggregate thickness sufficed for most of the project cross sections.

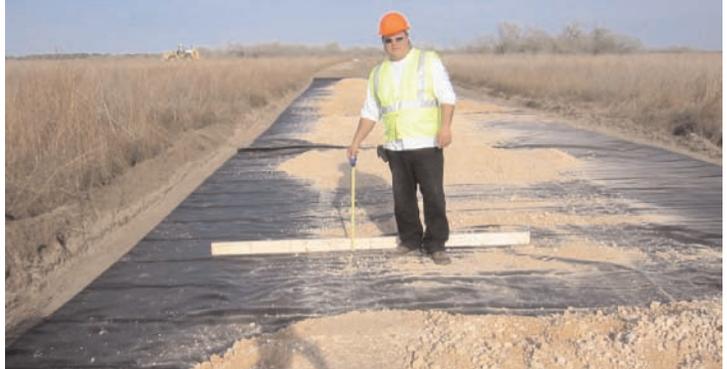
Mirafi® HP270 geotextile shows capsulation of base material in rutting zone.

Proof-rolling tests were performed on the caliche and subgrade both with, and without geotextile stabilization. Upon rolling over the caliche, where a Without geotextile stabilization, deformations of 2-3 inches occurred as shown in the adjoining photos. This deformation would have resulted in the loss of the imported caliche fill, both during initial road construction and long-term. Because of the high water table anticipated at many of the roadway locations, the geotextile stabilization must have very good permittivity, high strength at low strains (high tensile modulus). To meet these requirements, Mirafi® HP270 stabilization geotextile was selected for the project. A biaxial geogrid was also considered for haul road stabilization for the project but was rejected since the geogrid has large openings which would allow the intermixing of soft, wet subgrade soils with the caliche, resulting the degradation of the pavement section.

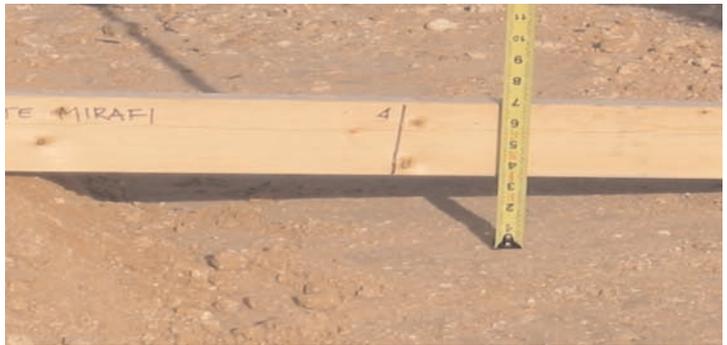
3" to 4" rutting after one pass of construction equipment.

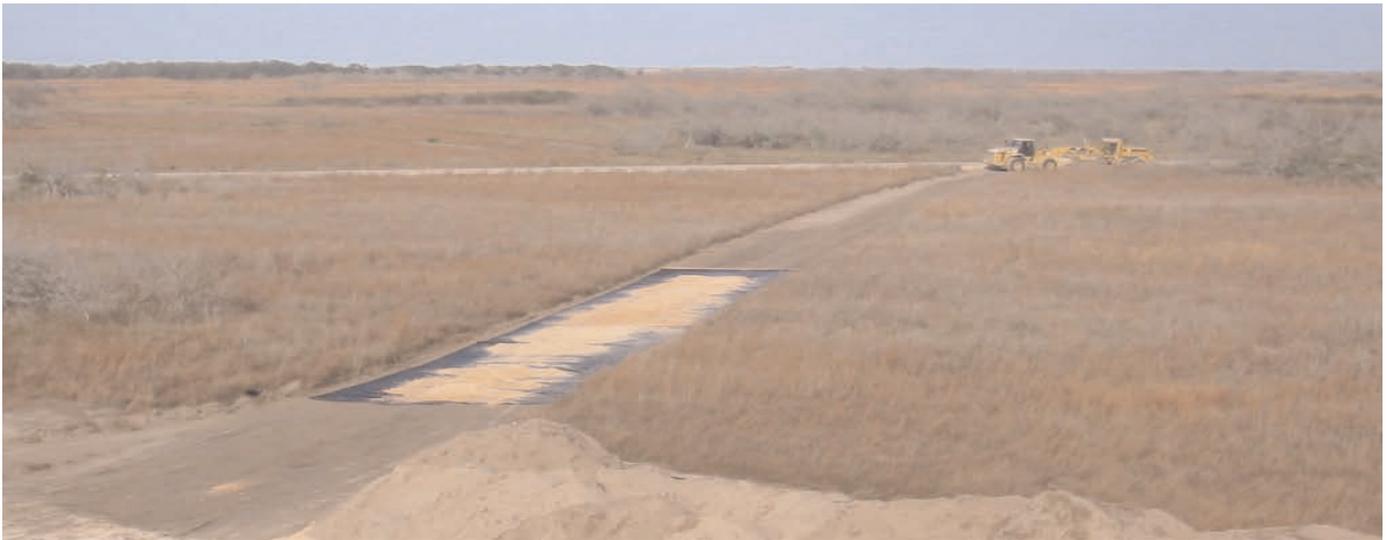
BELOW: Aerial view of test section.
