Case Study

application	Follow-Up: Base Course Reinforcement/Separation
location	Raleigh, NC
product	Mirafi® HP370 (13,000 SY)

job owner
engineer
contractor
installed

City of Raleigh
Withers and Ravenel
Brinley Contracting
January 2003

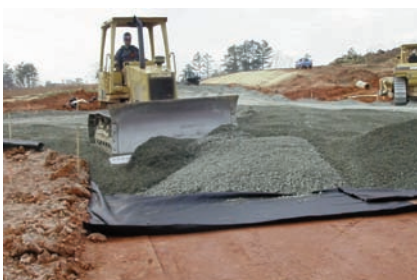
Mirafi® HP370 and base course being placed on the relatively firm subgrade.

Most of the subgrade soil conditions appeared to be relatively firm during the construction of the flexible pavement. The wide rolls of Mirafi® HP370 allowed the contractor to place the panels three wide with the required amount of overlap on these wide collector roads. The use of TenCate Mirafi® geosynthetics allowed the contractor to maintain the flexible pavement construction schedule for the project.

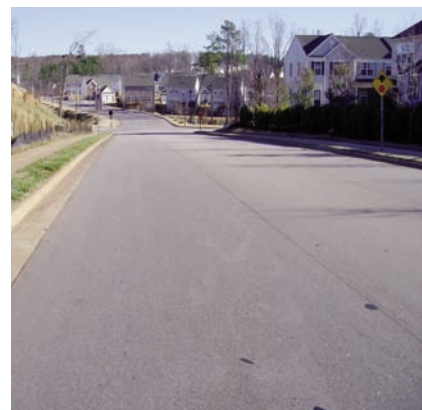
Country Trail 2007: Pavement looked as if it were newly installed.

When our original case study was completed in February of 2007, photos were taken of a repre-

sentative area on Country Trail where the geosynthetic was used as well as a section of Parkstone Drive constructed without the benefit of a geosynthetic about 6 months prior.

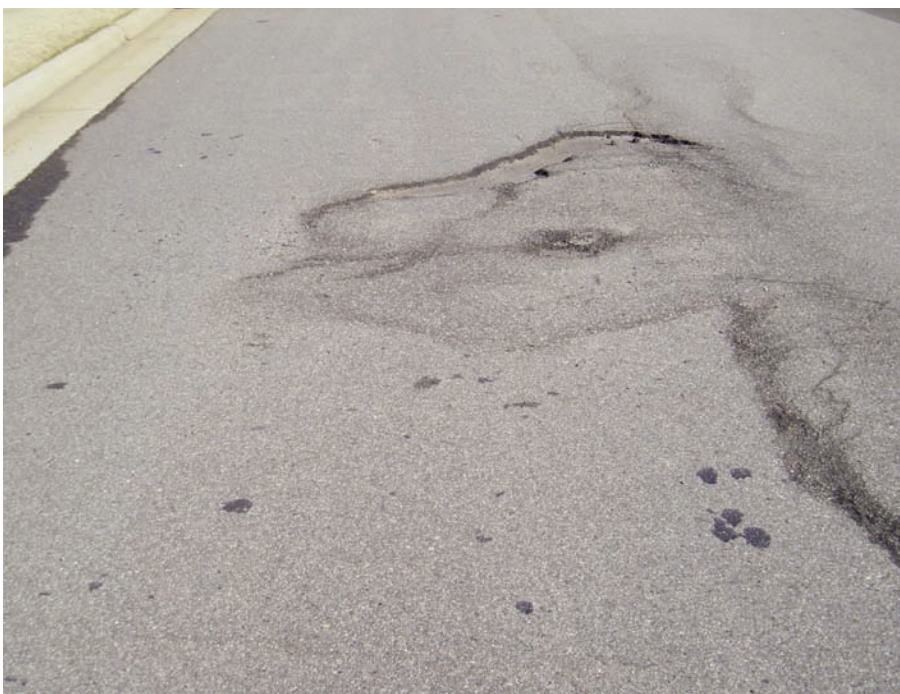
2007: Without the benefit of geosynthetics, Parkstone showed signs of premature deterioration.

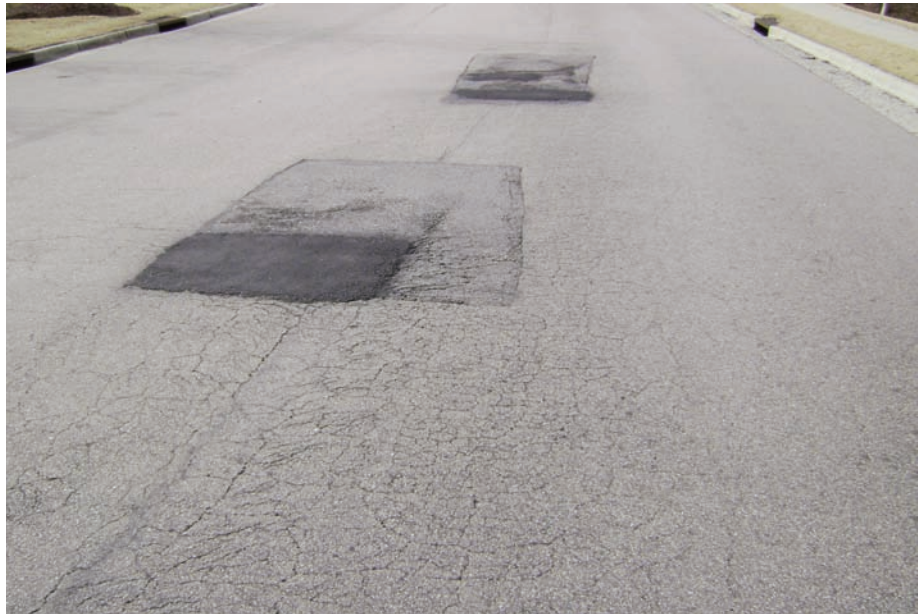
Country Trail without Mirafi® HP370 in 2011 already had areas re-sealed and shows signs of major alligator cracking.

In February of 2011, these same areas were investigated and new photos were taken noting any changes that have occurred. The sections of Country Trail and Marvino Lane where the Mirafi® HP370 was installed showed no major pavement deterioration. The asphalt has shown a bit of wear, but nothing that would indicate a deteriorating subgrade or any base course problems. The Parkstone Drive area constructed without a geosynthetic has continued to deteriorate. It appears as though a section of the pavement has been replaced and areas adjacent to the repair are starting to show major signs of fatigue. Another area of pavement with signs of premature deterioration was observed further into the development on Country Trail, beyond where geosynthetics were used. This part of Country Trail was built approximately 1 year after the first pavement areas that incorporated geosynthetics.

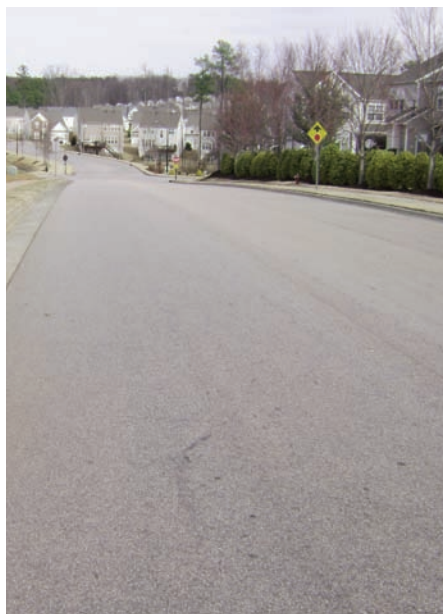
Country Trail with Mirafi® HP370 in 2011, still performing very well.

Roadway areas that used Mirafi® HP370 continue to perform much better than the other areas that did not use any geosynthetics in their construction. In addition, the pavement sections where Mirafi® HP370 was used look to have a higher ADT than the other two areas. The ability of the geosynthetic to provide reinforcement, confinement of the graded aggregate base course and separation of the base course from the silty subgrade conditions added over 10% to the structural number of the unreinforced pavement section. This additional structural number benefit nearly doubles the allowable ESAL's under the same subgrade conditions.

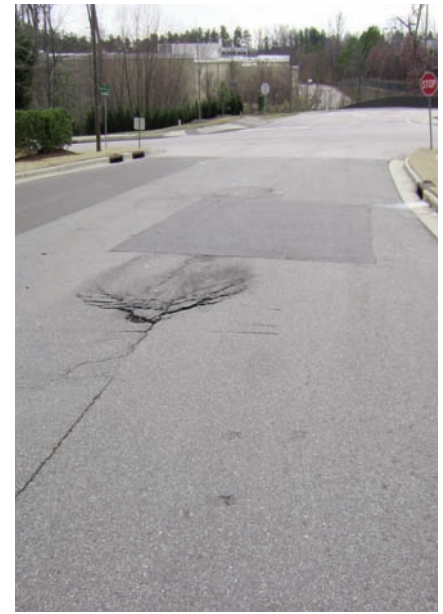
Parkstone 2011: Pavement deterioration continues where the area was replaced.
