CASE STUDY **Battling Frost Heave** on the **Alaskan Highway**

Mirafi[®] H₂Ri

Frost Heave/Subgrade Stabilization

Dalton Highway, AK

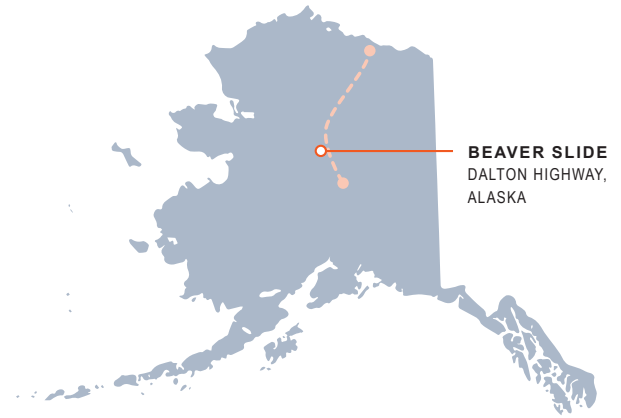
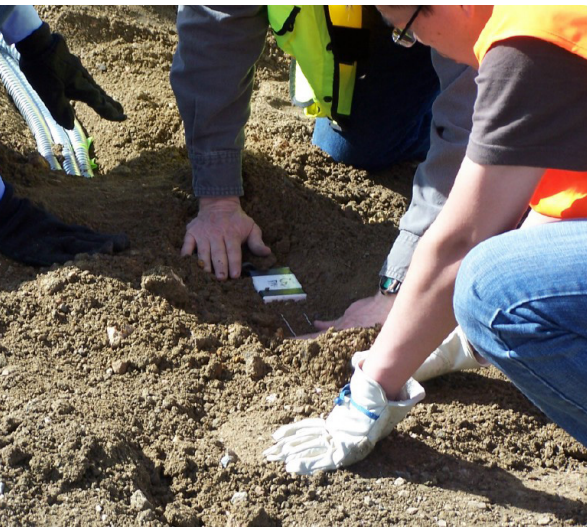
Excavation of the existing road confirmed that an organic tundra layer was approximately 4-5 feet below the road surface. Frozen soil was also encountered along with water from the high ground water table. After excavation, two layers of Mirafi® H₂Ri were Rapidly installed 18" apart with the first layer installed directly on the subgrade. Sensors were placed below and above the first layer of Mirafi® H₂Ri and finally sensors were placed above the second layer. The sensor leads were all bundled together and buried in a trench that led to a data collection unit on the side of the road.
