Wicking Geosynthetic Used for Frost Heave Prevention Pioneer Mountain Scenic Byway

Prepared for the 65th Highway Geology Symposium, July, 2014

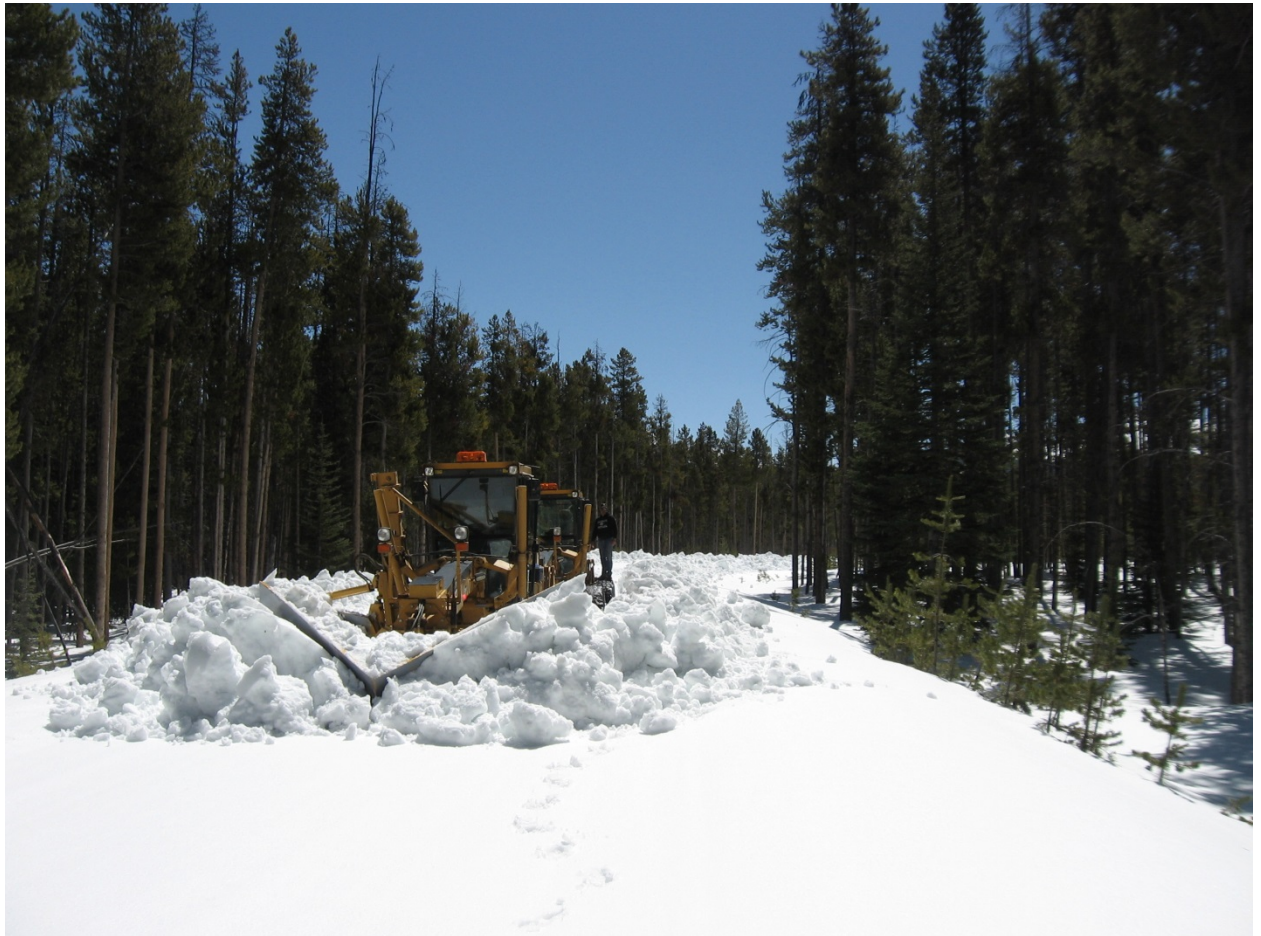
Figure 1 – Road Clearing

The road is typically cleared from snow in late April-early May (Figure 1). Once uncovered, a longitudinal crack forms during the freeze-thaw cycle (Figure 2), and extends for over 20 miles, some of which are wider than a motorcycle tire and requires immediate maintenance attention for safety. The Moose Park location displays the most severe of these cracks generated by freeze thaw.

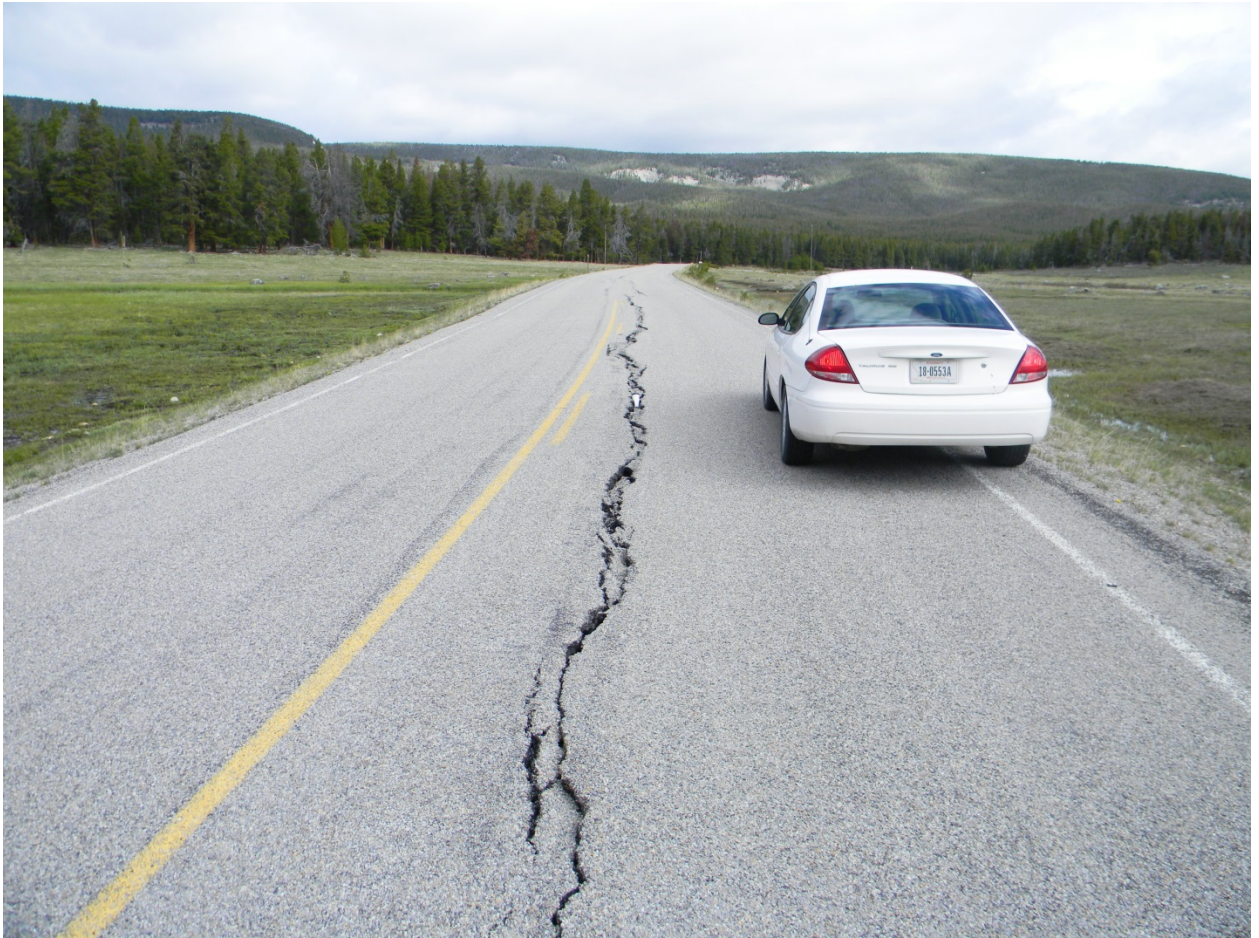
Figure 2 – Longitudinal Crack, Moose Park

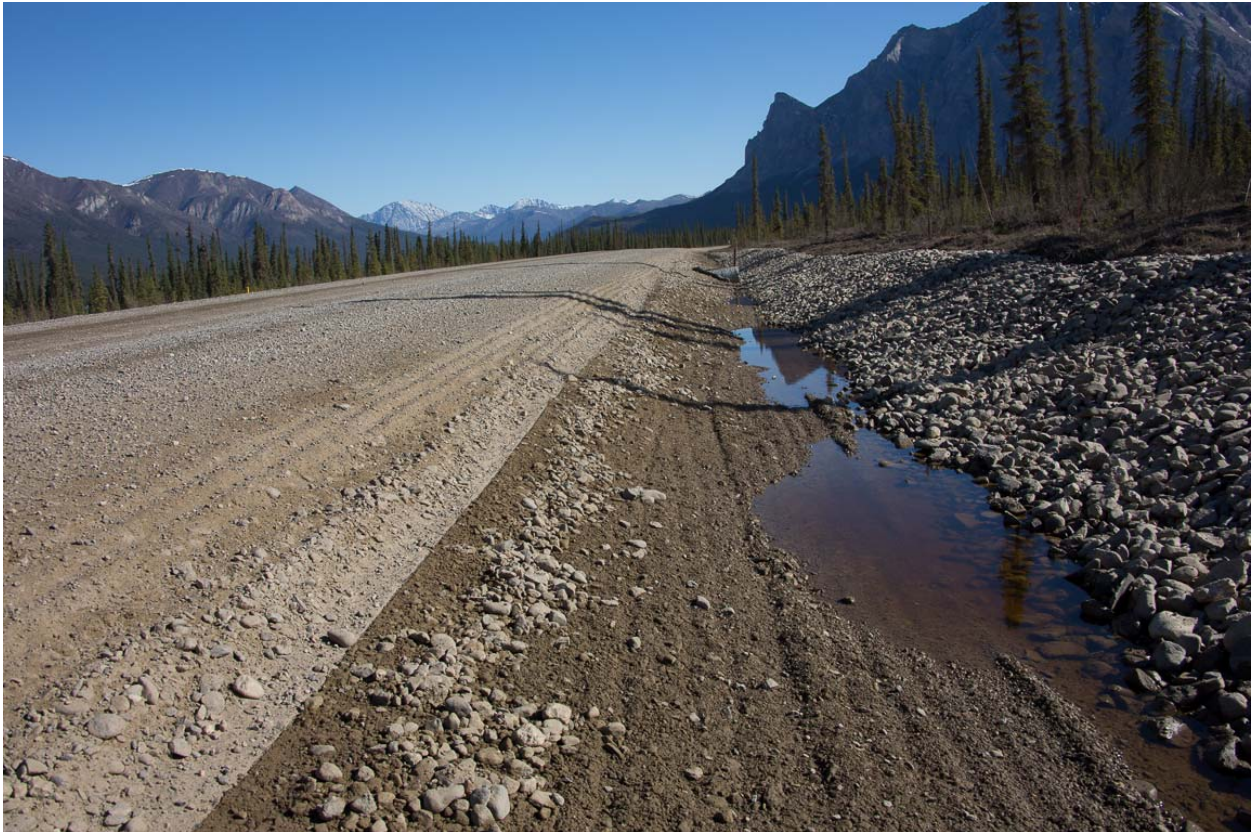
Figure 5 –Dalton Highway - Mirafi H2Ri capillary break and wicking seen May 30, 2013

Another project of a much larger scale was installed in 2012 by the Alaska DOT on the Dalton Highway 30 miles north of Coldfoot, Alaska. This road experiences severe frost heave and early success of the geosynthetics wicking capability was seen during the first spring break-up. (Figure 5)

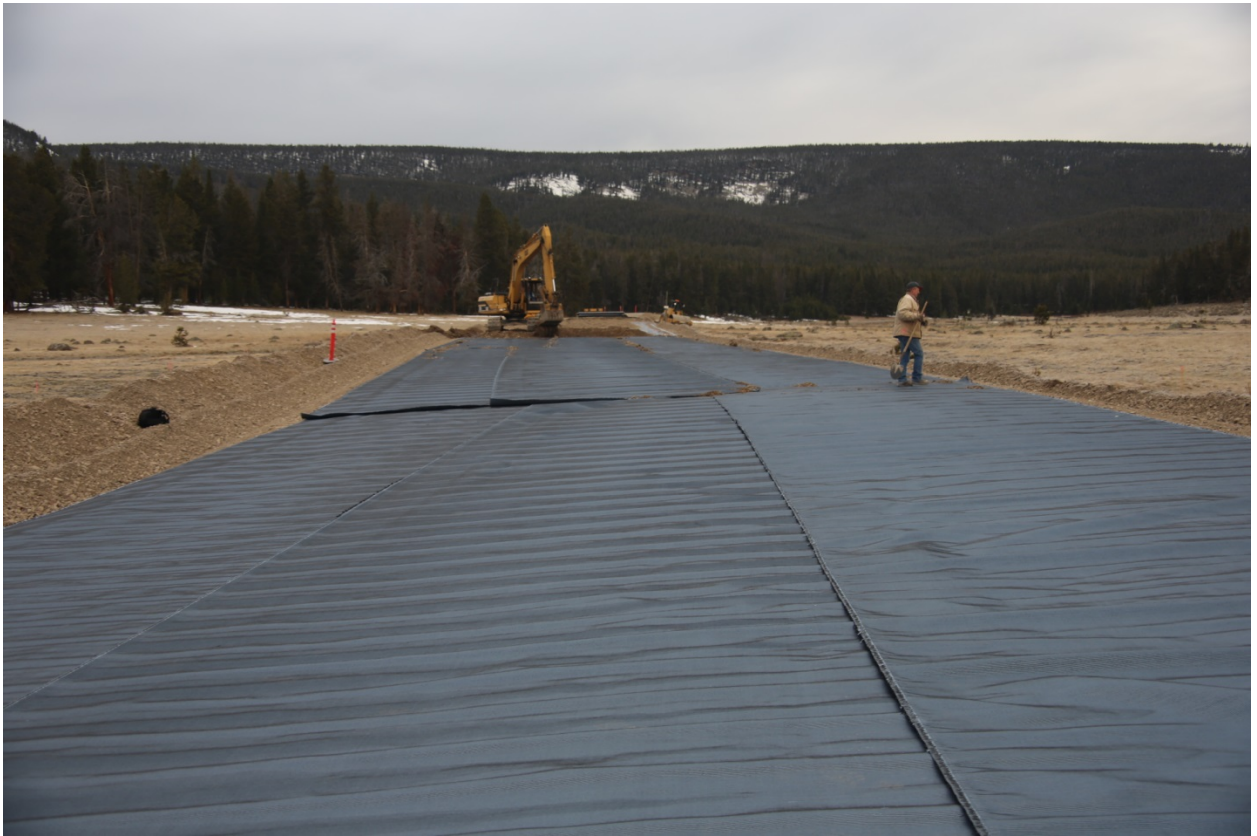
Figure 7 – Overlap in Super Elevation

Beaverhead County Engineer was onsite along with technical representation from TenCate. Often geosynthetics are installed with a minimum overlap requirement. In the case of the wicking geosynthetic, the overlaps were installed “shingle style” so as to optimize water movement to the sides of the road. In super elevation cases, the material was overlapped from one side of the road to the next (Figure 7), and for a typical crown, the material was installed with the middle roll at the highest point similar to a roof shingle. (Figure 8)

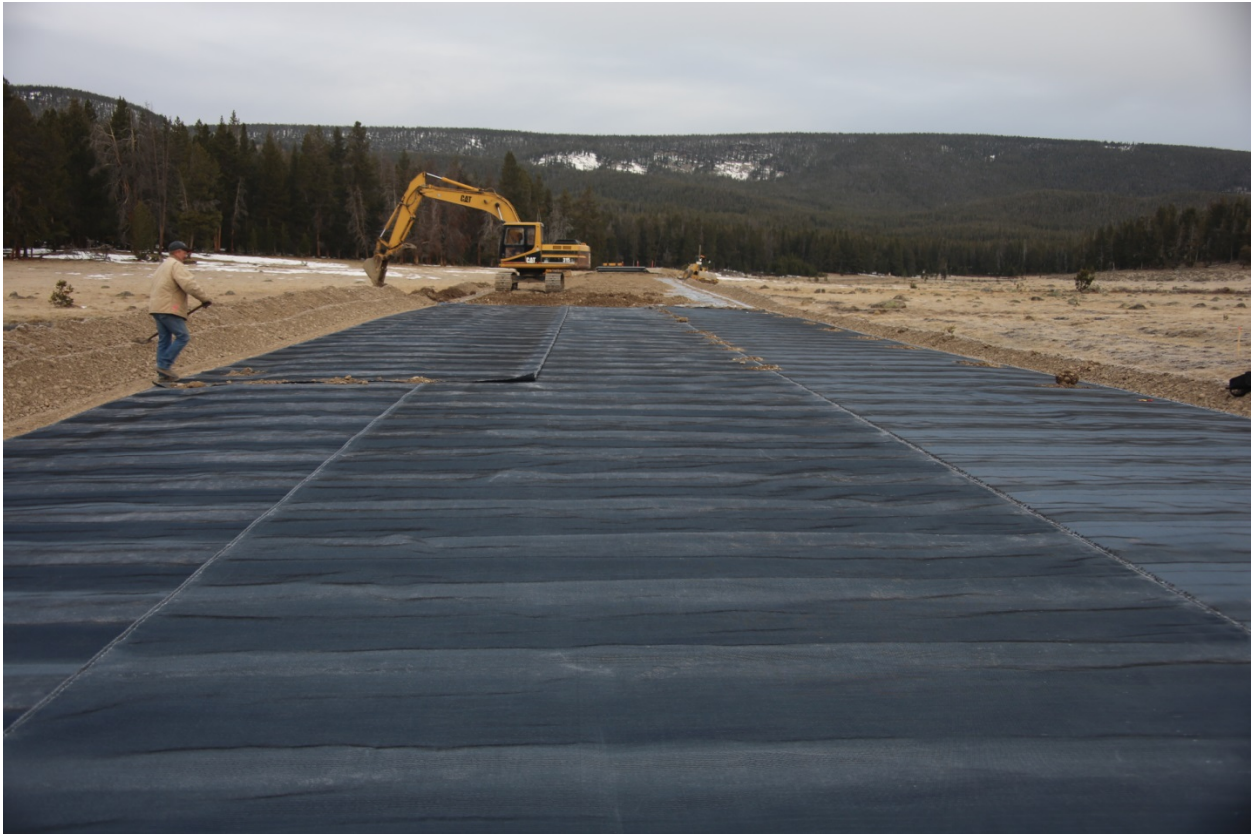
Figure 8 – Overlaps transitioning from Super Elevation to Crown
