Moisture Mitigation under Steepened Slopes

Mirafi[®] H₂Ri

Moisture Mitigation under Steepened Slope Repair

Kelso, WA

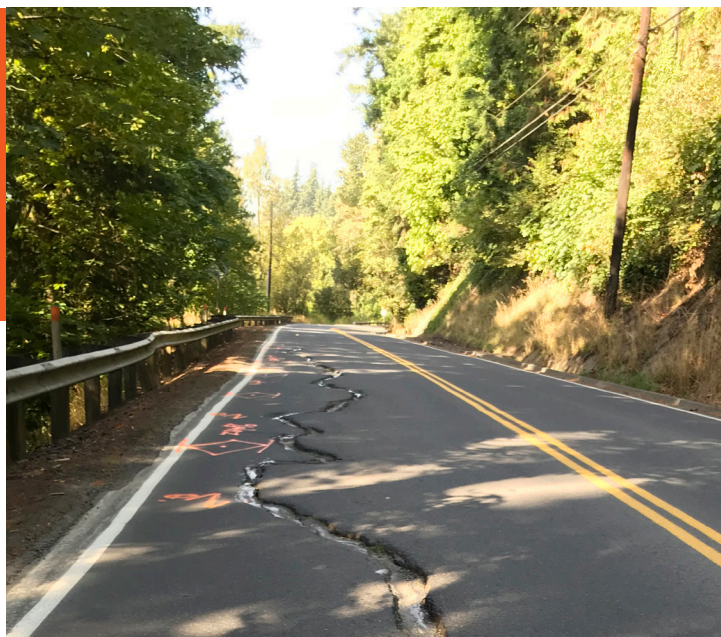
The Old Pacific Highway is the original freeway section which runs parallel to the current Interstate 5. Nestled up in the hillside, a global stability issue created a slide of the natural slope and a large crack in the pavement section. This project was treated like a deep patch repair and initial repair strategies conceptually included the removal and disposal of the existing asphalt roadway and aggregate subbase, over-excavation of native subsurface soils to a depth anticipated between 2-6 feet, the installation of 4 layers of geogrid in combination of CSBC, and HMA surfacing. However, during geotechnical exploration, an area of high saturation was noted at the bottom of the slip zone, approximately 6 ft. down from existing road surface. The project team was worried that if they repaired this section without addressing the moisture issue, it wouldn't be long until it the same section of roadway required additional repair.

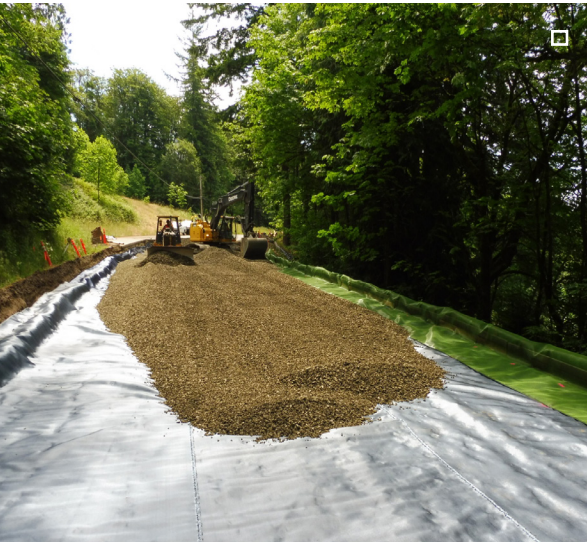
The existing asphalt roadway and aggregate subbase was removed to a depth of 6 feet. The bottom of the excavated area was graded to direct water flow from the back cut of the excavation to the slope face and Mirafi® H₂Ri was installed at the bottom of the excavation. Eight (8) inches of six inch minus gravel backfill was used between the H₂Ri and RS380i. Above the RS380i, a reinforced slope was constructed using layers of biaxial geogrid (BXG120) and Miramesh® for the facing (which takes the place of secondary reinforcement with a 75-year exposed design life and an erosion control blanket to promote vegetative growth). CBSC with a top size of ¾" was used for the steepened slope fill. The Miramesh® will allow for quick vegetation and soon the repair will be hidden amongst the natural greenery.
