Mitigating Moisture in Railway Subgrade

Mirafi[®] H₂Ri and RS580i

Railway Reinforcement

Edmonton, Alberta

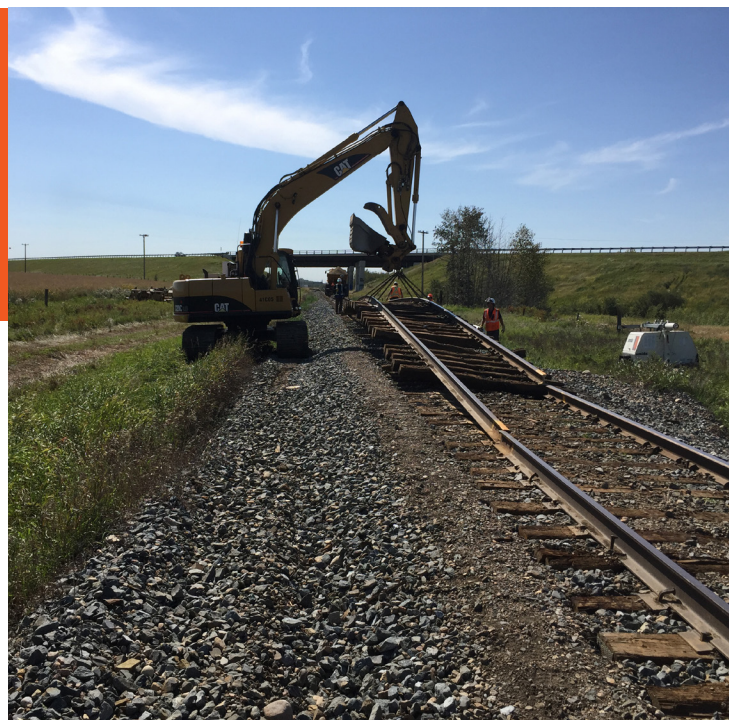
Canadian Pacific's (CP) continuous rail maintenance and safety program identified a section of track on a site located 30 minutes, northeast of Edmonton, Alberta that was subject to track settlement resulting in cross level variations. CP implemented a 10 mph speed restriction on the section of track and scheduled it for immediate repair. Field investigations showed that a significant amount of moisture was present in the subgrade and surrounding area. Signs of mud-pumping (movement of subgrade material into the coarse ballast) were apparent along the track surface, indicating that the wet conditions were accentuating the process of subgrade attrition and that the sub-ballast was no longer performing as originally intended.

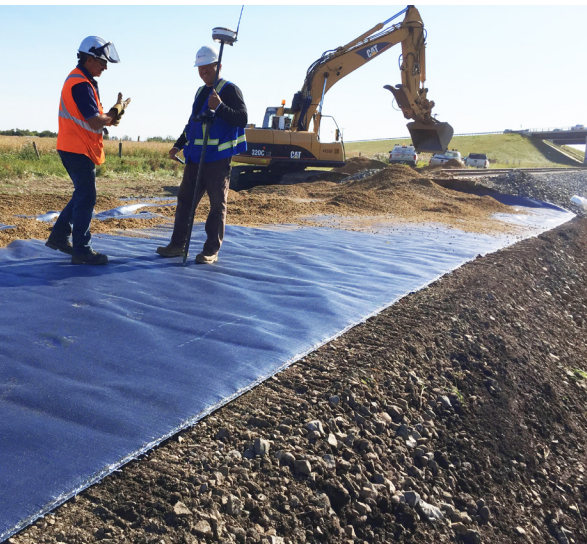
Repair of the first 22 meter-long section was completed in just under 7 hours. Removal of the track panel and excavation/removal of the existing rail embankment was completed in approximately 1 hour. Mirafi® H₂Ri was rapidly placed on the prepared subgrade, backfilled with sub-ballast, and compacted in under 90 minutes. The sequence of events from this point onward was placement of the Mirafi® RS580i, reconnection of the track panel, ballast placement, ballast compaction, and grade correction with the regulator. Placement of the geosynthetic was a minimal amount of the 4 hours required to perform these last steps.
