Case Study

application Railway Reinforcement
location Scotford, Alberta
product Mirafi® RS580i and H2Ri

Canadian Pacific Railway (CP)
Clifton Associates
2016

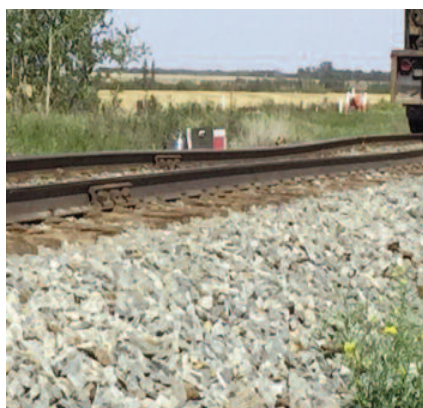
CP's continuous rail maintenance and safety program identified a section of track on the Scotford Subdivision, northeast of Edmonton, Alberta that was subject to track settlement resulting in cross level variations. CP implemented a 10 mph speed restriction on the section of track and scheduled it for immediate repair.

Unrepaired track section with cross level variation due to settlement issues.

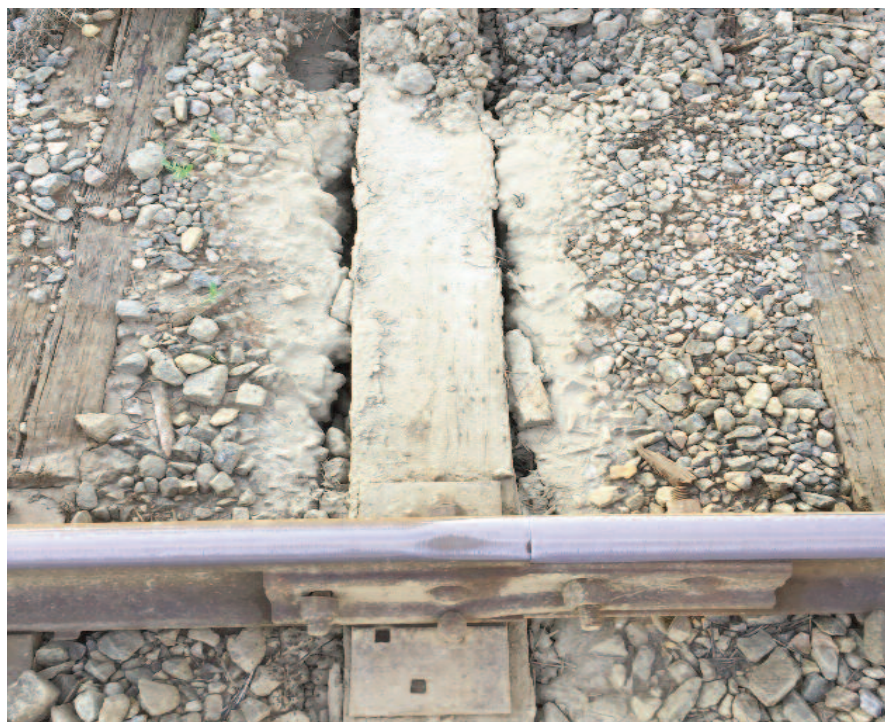
Clifton Associates, a leading Western Canadian geotechnical engineering firm with expertise in railway infrastructure, was brought on board by CP to investigate potential causes and prescribe a repair. Field investigations showed that a significant amount of moisture was present in the subgrade and surrounding area. Signs of mud-pumping (movement of subgrade material into the coarse ballast) were apparent along the track surface, indicating that the wet conditions were accentuating the process of subgrade attrition and that the sub-ballast was no longer performing as originally intended.

Evidence of mud pumping and ballast contamination prior to repair.

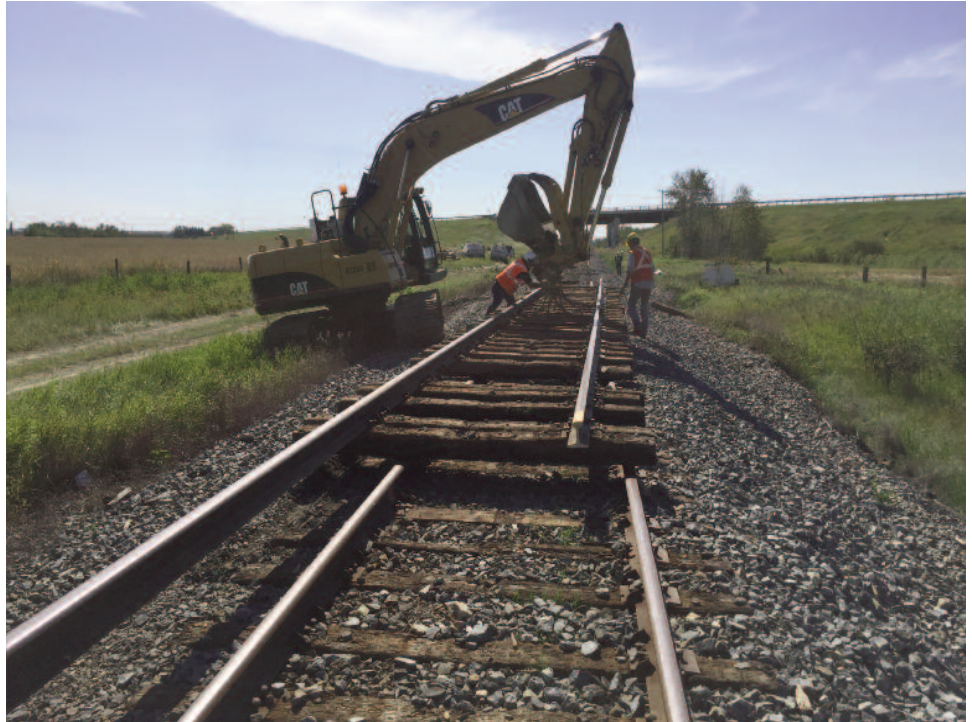
Track panel is removed.

Repair of the first 22 meter-long section was completed in just under 7 hours. Removal of the track panel and excavation/removal of the existing rail embankment was completed in approximately 1 hour. Mirafi® H₂Ri was placed on the prepared subgrade, backfilled with sub-ballast, and compacted in under 90 minutes. The sequence of events from this point onward was placement of the Mirafi® RS580i, reconnection of the track panel, ballast placement, ballast compaction and grade correction with the regulator; Placement of the geosynthetic was a minimal amount of the 4 hours required to perform these last steps.

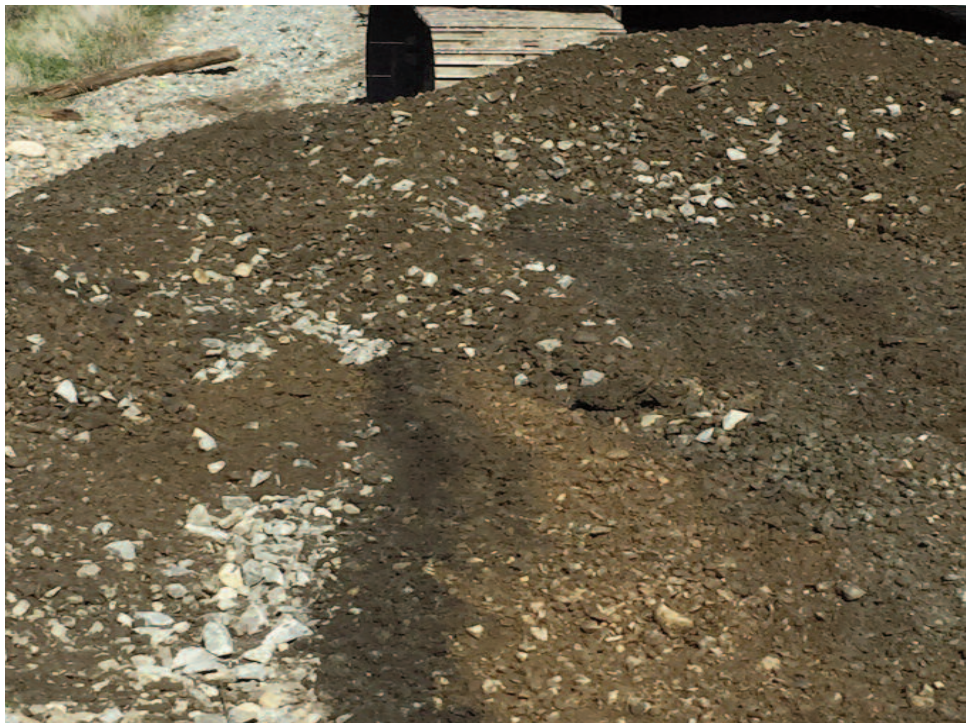
Contaminated rail ballast: The dark material is topsoil that has migrated into ballast. The lighter area is sub-ballast, which has migrated into ballast.

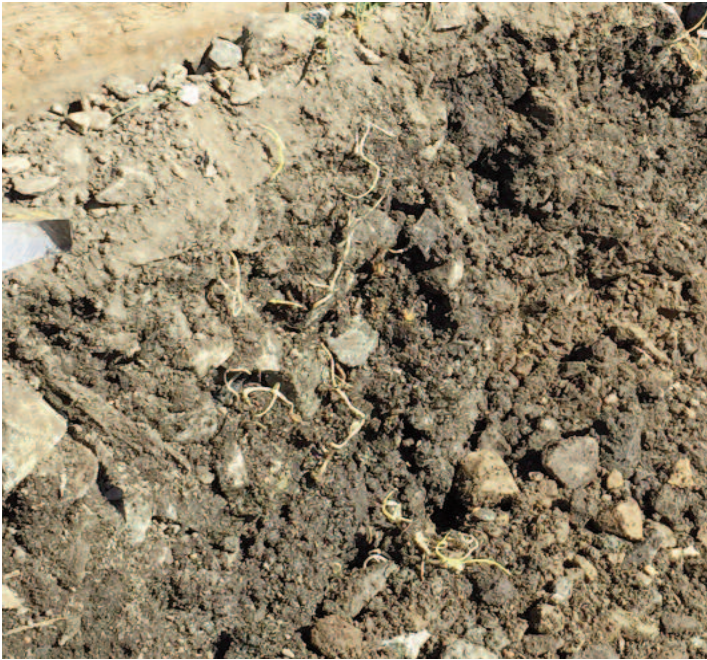
Ballast contamination and moisture enough to support plants and root systems.

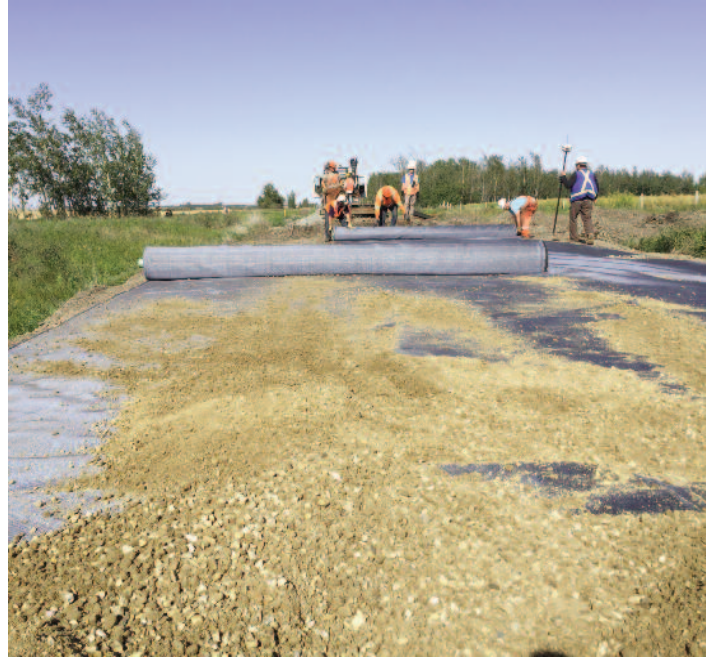
Mirafi® H2Ri installed at the subgrade/subballast interface.

Due to the urgent nature of the repair, CP ultimately decided to select the TenCate solution for the assumed worst case subgrade condition which incorporated Mirafi® H₂Ri wicking geosynthetic at the subgrade and Mirafi® RS580i at the sub-ballast/ballast interface. Generally, the weaker the subgrade, the more benefit the geosynthetic provides.

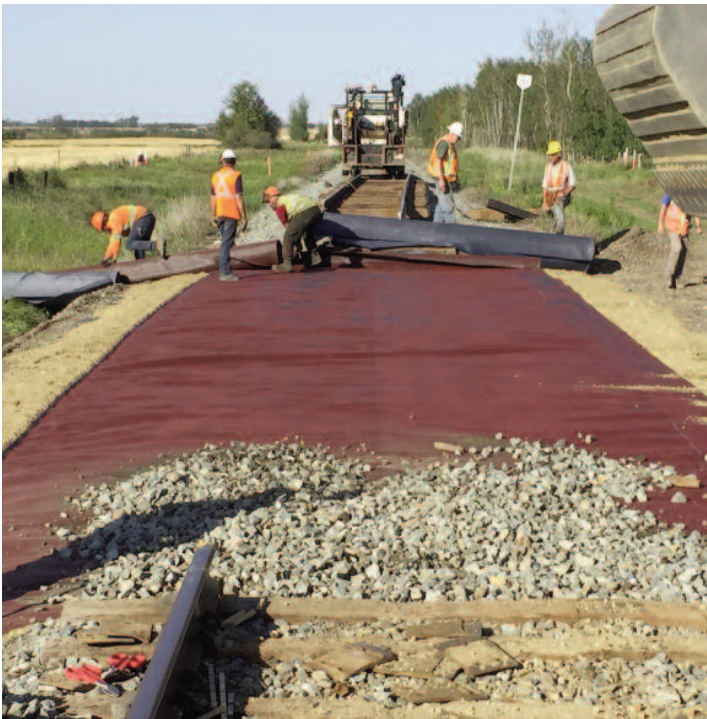
Mirafi® RS580i installed at the ballast/sub-ballast interface.

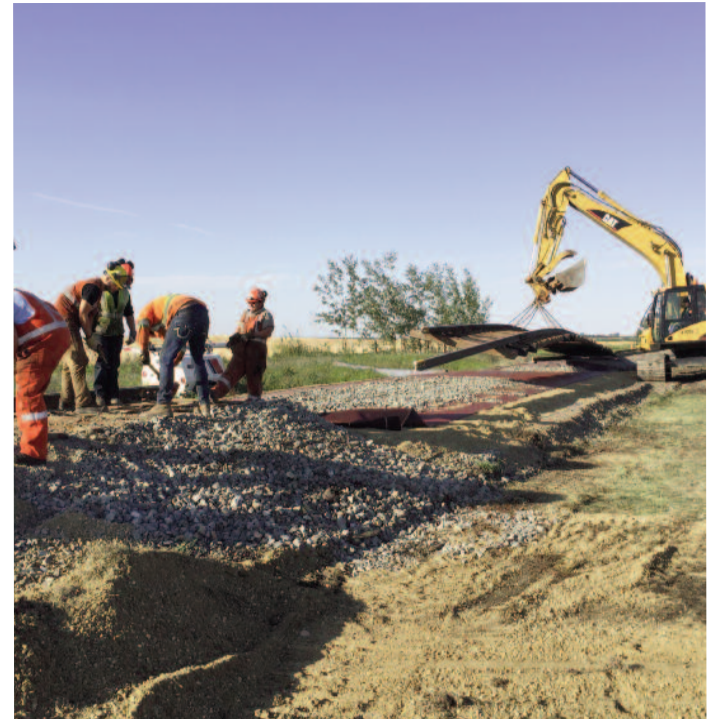
Reconnecting the track panel.

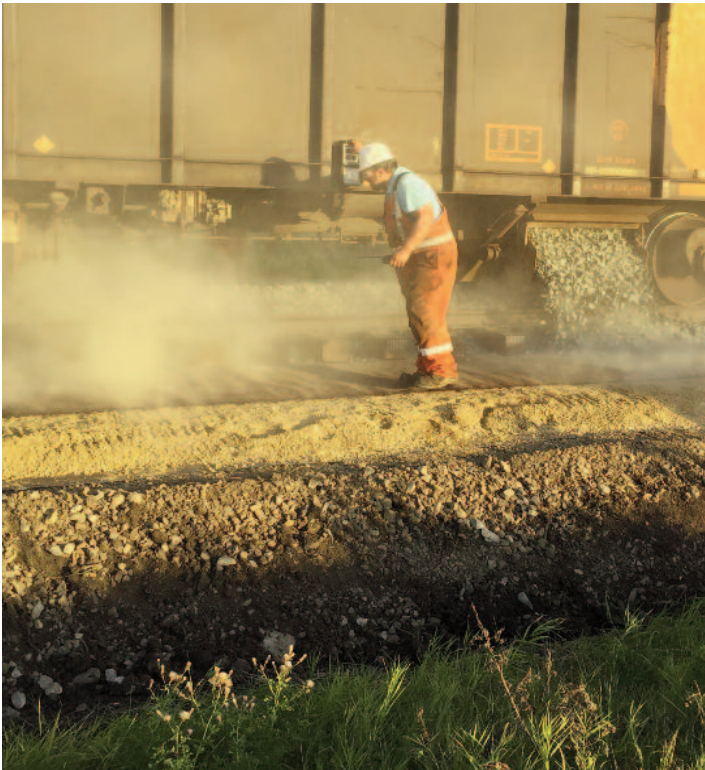
Placing new ballast.

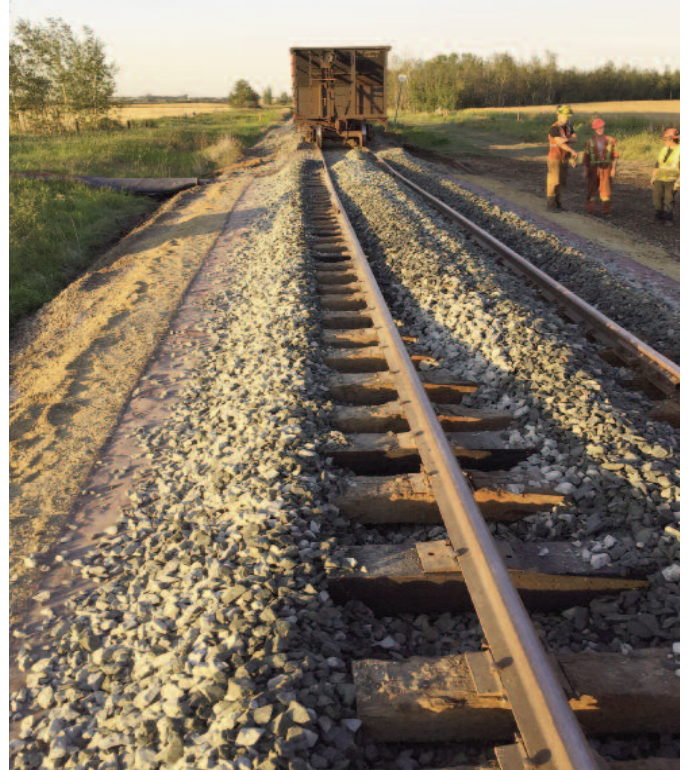
Placing new ballast.

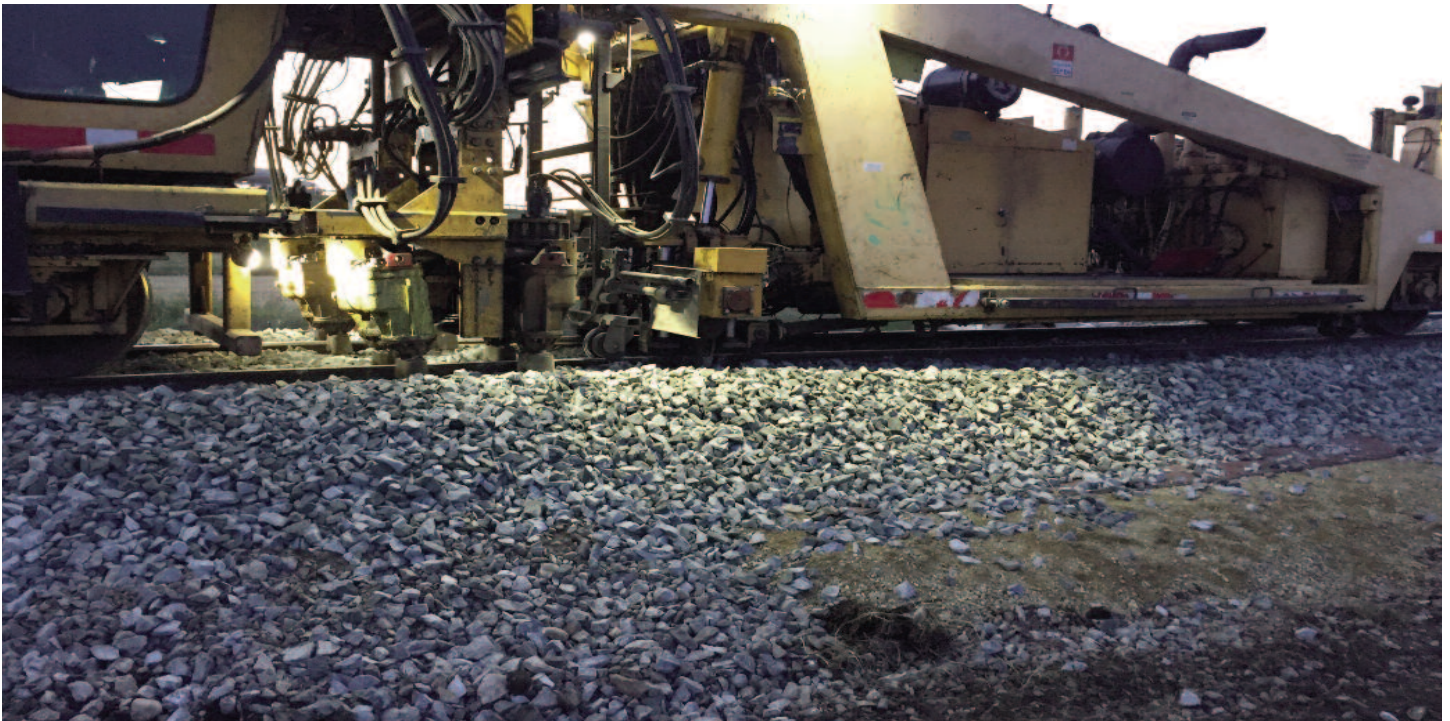
Lifting rail and compaction of ballast under rail ties.

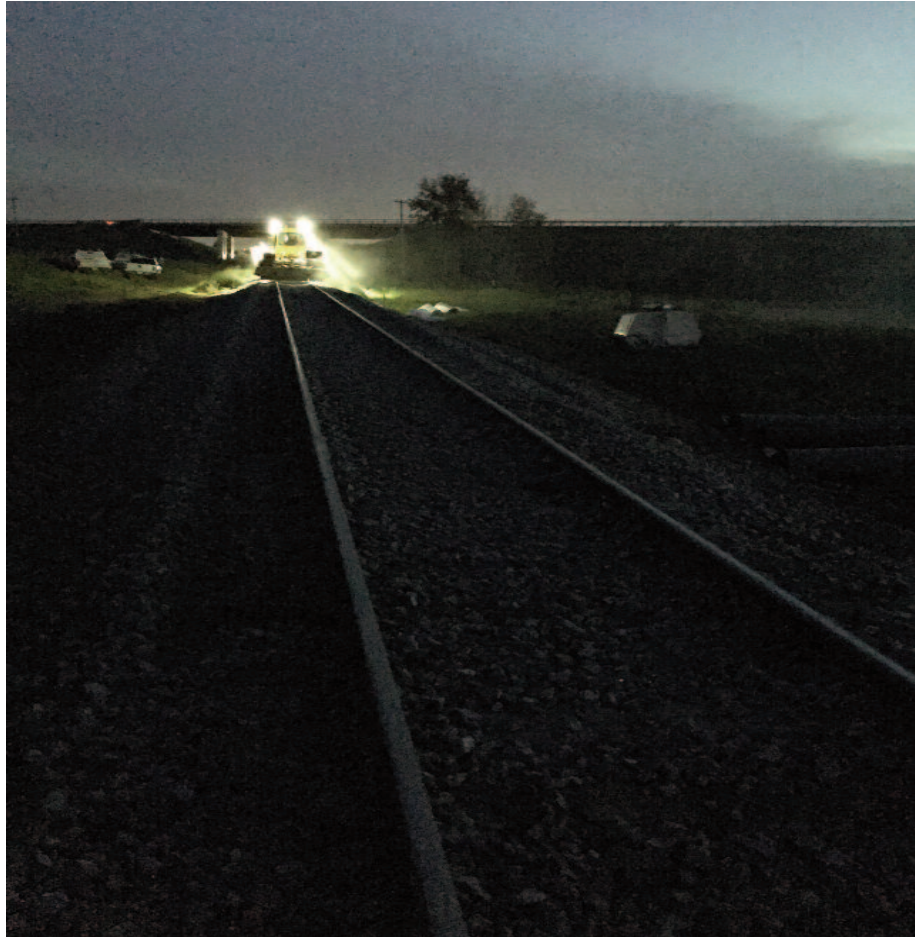
Installation complete.

CP will be monitoring the track performance on the repaired subgrade over the next few years. The expectation is that they will know the level of performance after the first Spring freeze, when the subgrade is expected to have the maximum moisture content.
