Reconstructing Frost Heave Roads in Weare, NH

Mirafi[®] H₂Ri

Base Reinforcement & Moisture Management

Weare, NH

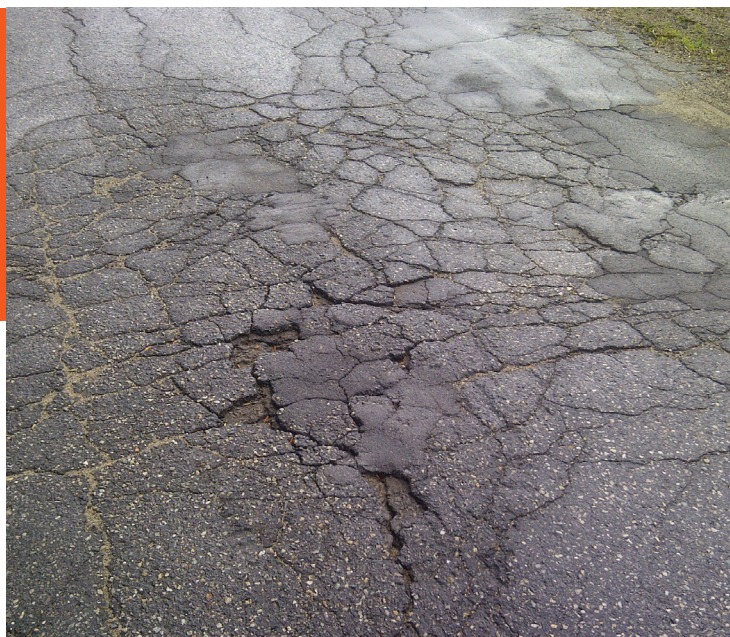
As part of the Road Reconstruction Program in the Town of Weare, NH, 4200 lf of Flanders Memorial Road was scheduled for reclaiming and reconstruction of the base course followed by a shim and pavement overlay. Flanders Memorial Road meandered through various steep grade changes that created extreme pavement distress. The existing roadway was showing signs of fatigue due to drainage issues, rutting caused by high water tables and reduced shear strength, and most concerning was the frost heave issues that were detrimental to the roadway. The challenge for the town was to address the frost heave issue and rebuild the road with better rideability quality while making it safer for the increased amount of traffic. It was also important to reconstruct the roadway rapidly and within a tight budget while providing a robust roadway that lasts for years.

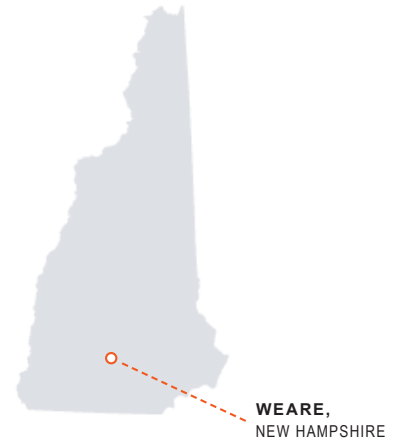
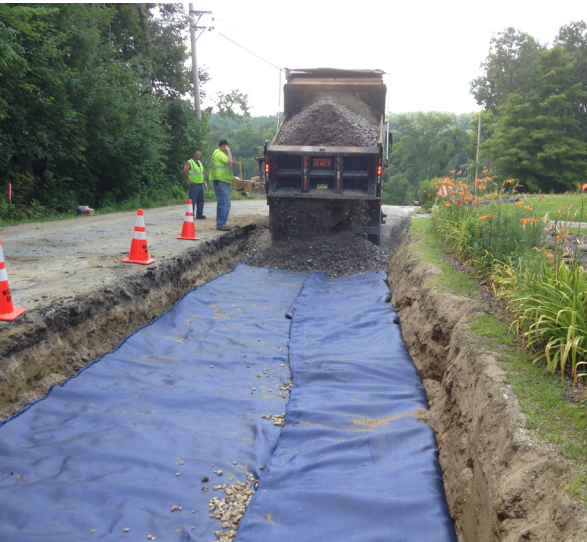
Once excavation of the existing 3' was completed, a perforated drainage pipe was installed on the edge of the cut. A layer of Mirafi® H₂Ri was rapidly installed on the subbase and a 12" thick lift of 1 ½" minus aggregate was placed and compacted. Mirafi® H₂Ri was placed such that the roll ends ended in a trench drain to rapidly manage the moisture of the system. After compacting this base layer, Mirafi® 160N nonwoven geotextile was placed to act as a separator for another 12" lift of 3" minus crushed ledge rock road base. This layer was rolled and capped with another 12" layer of 1 ½" minus crushed bank run gravel. This layer was compacted and then the shim and pavement overlay was constructed.

Due to the varying base conditions, it was determined that the roadway sections be excavated 3 feet. In addition, drainage pipe was to be installed and daylighted to alleviate water issues. In order to improve the base conditions and help with the frost heave issues the Town decided to use Mirafi® H₂Ri, a high strength reinforcement geosynthetic which would provide the much needed separation, reinforcement, drainage and confinement of the base materials and provide moisture management of the wet soils.
