Expert Corner

DALTON HIGHWAY MP197-209 REHABILITATION

Mirafi® H₂Ri Product Spotlights

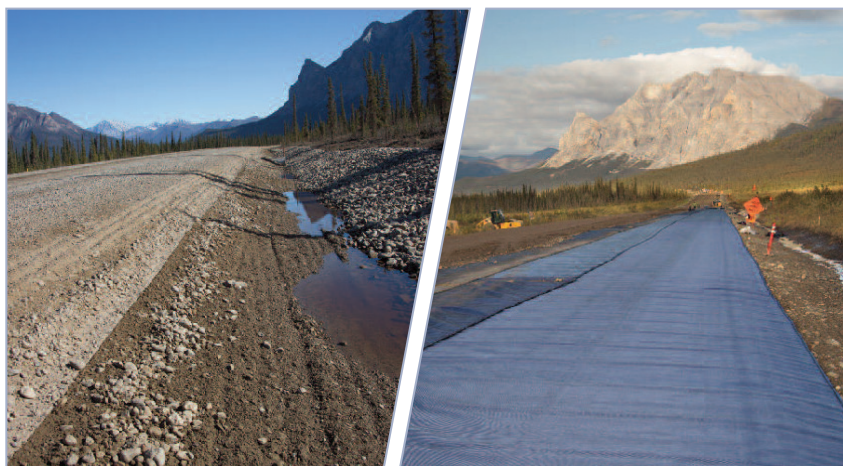
The Alaska DOT&PF recently issued a final report entitled “H₂Ri/Wicking Fabric Experimental Feature Final Report – Dalton Highway MP 197-209 Rehabilitation.” In this project, Mirafi® H₂Ri – a geotextile with unique hydraulic wicking properties – was used to address drainage issues that led to regular occurrences of differential frost heaving.

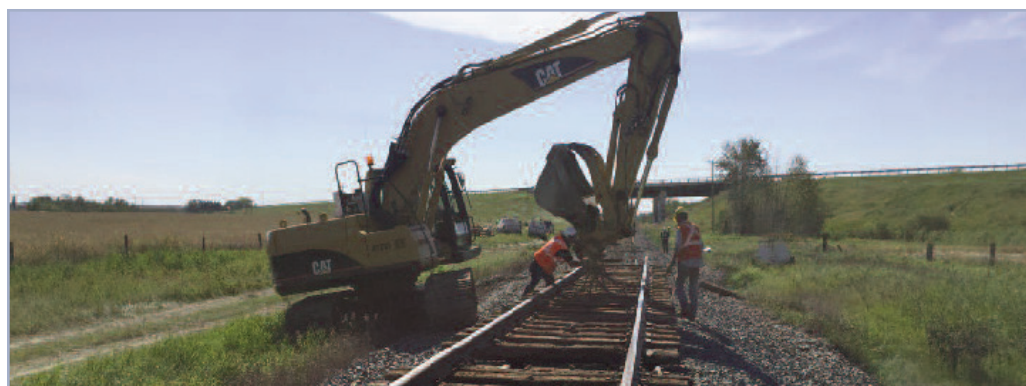
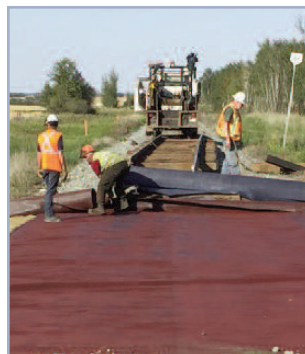
Application: Railway Reinforcement **Location:** Edmonton, Alberta

Canadian Pacific's (CP) recently identified a section of track on a site located 30 minutes, northeast of Edmonton, Alberta that was subject to track settlement, resulting in cross level variations.

Moisture was present in the subgrade and surrounding area, and signs of mud-pumping were apparent along the track surface, indicating that the wet conditions were accentuating the process of subgrade attrition and that the sub-ballast was no longer performing properly.

They decided to incorporate Mirafi® H₂Ri wicking geosynthetic at the subgrade and Mirafi® RS580i at the sub-ballast/ballast interface, which resulted in a 43% reduction in the amount of ballast and sub-ballast required.

Mirafi® H₂Ri was placed on the prepared subgrade, backfilled with sub-ballast, and compacted in under 90 minutes. Finally, placement of the Mirafi® RS580i, reconnection of the track panel, ballast placement, ballast compaction and grade correction with the regulator was performed in 4 hours.

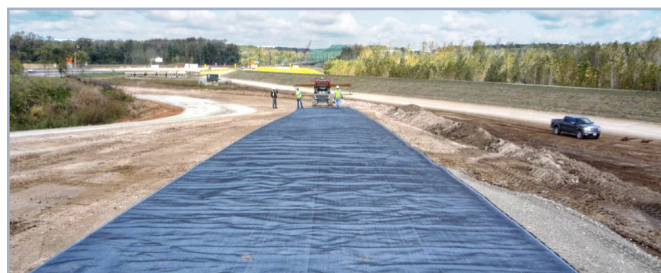
Application: High Water Table – Subgrade Stabilization **Location:** St. Louis County, MO

A new bridge was being constructed over the Missouri River where saturated soil conditions required water to be removed from under the pavement section at the bridge approaches. The Missouri DOT design build team originally designed a pavement section that included a concrete section over 4" of road base aggregate, 4" layer of drainable aggregate, and a prepared subgrade. Mirafi® H₂Ri geosynthetic allowed for an overall 2" reduction in aggregate base material along with the ability to wick water from under the pavement. The initial installation of Mirafi® H₂Ri began on a Thursday and was completed along with the placement of 6" of compacted aggregate. The day after the geosynthetic was placed, the project site received 1/4" rainfall and wicking was evident where the Mirafi® H₂Ri was installed.
