Case Study

Subgrade Improvement Greeley, CO

Mirafi® HP570

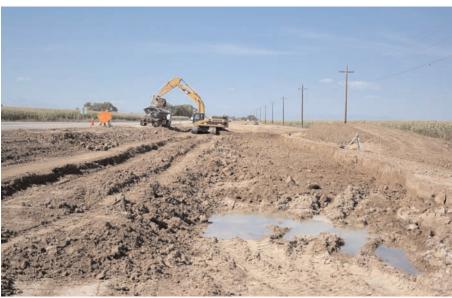
Condition of existing roadway after the section was torn out.

State Highway 34 in Greeley, Colorado was being reconstructed. This included tearing out the existing roadway section, rebuilding the sub-base, base and pavement. Soft soils and groundwater were discovered once the section was torn out. This made re-construction very difficult. Colorado Department of Transportation (CDOT) and Castle Rock Construction Company (CRCC) both investigated options to ease the reconstruction of this highway.

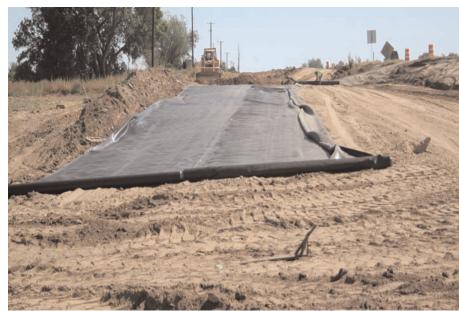
Installation of Mirafi® HP570.

The installation of the newly designed highway went smoothly. The Mirafi® HP570 was rolled out with appropriate overlaps for the soil conditions, the Class 6 base material was pushed out in front of a loader, spread and compacted on Mirafi® HP570 in one foot lifts.

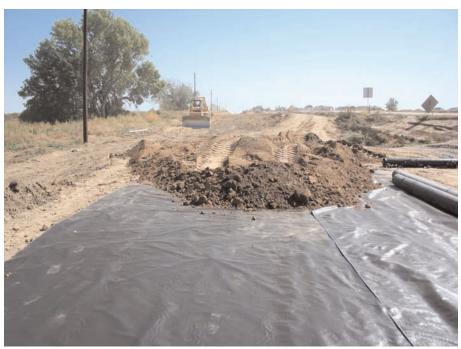
Backfill over Mirafi® HP570.
